# Pilot PedRail Bumpouts – DeziignLine 2017 Evaluation Summary

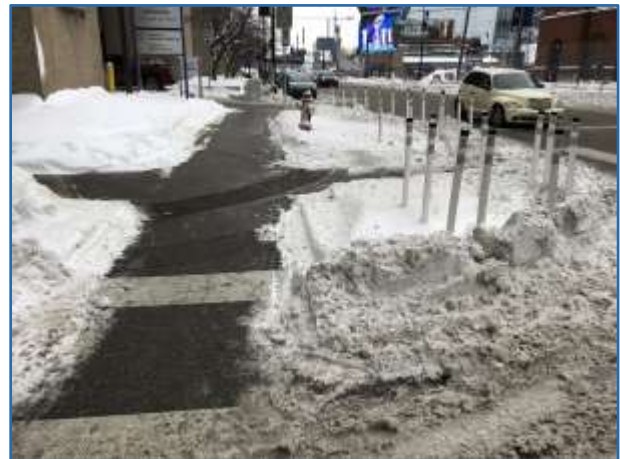
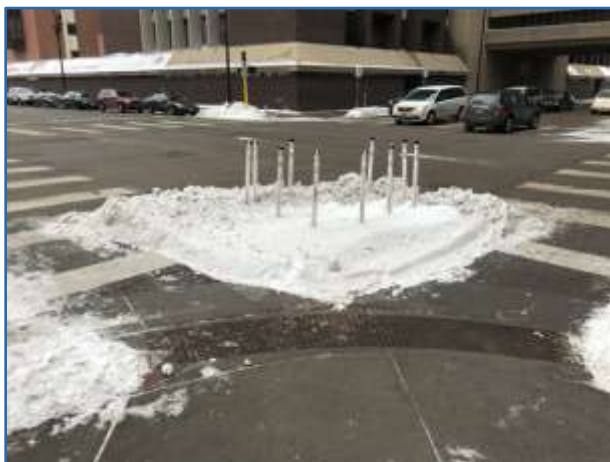
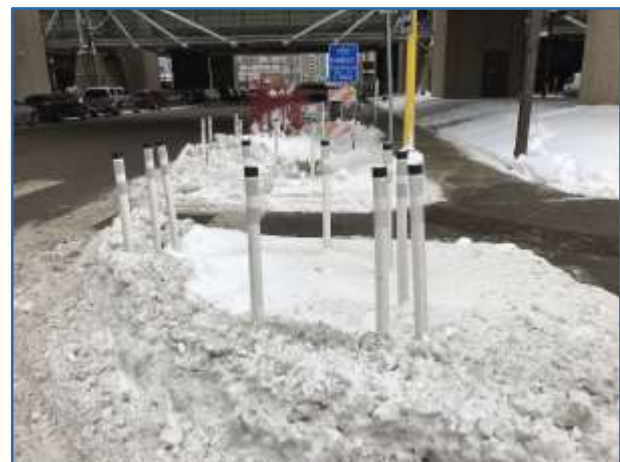
- There were no challenges reported from plow drivers. Heard feedback from TM&R staff that “they just plowed around them.”
- The adjacent properties – HCMC and the church agreed to remove snow left in the crosswalk
