PROJECT: 927-931 West Broadway
Minneapolis, MN 55411-2615

DATE: October 13, 2017
FILE NO.: RM0309

ROOF MANAGEMENT REVIEW

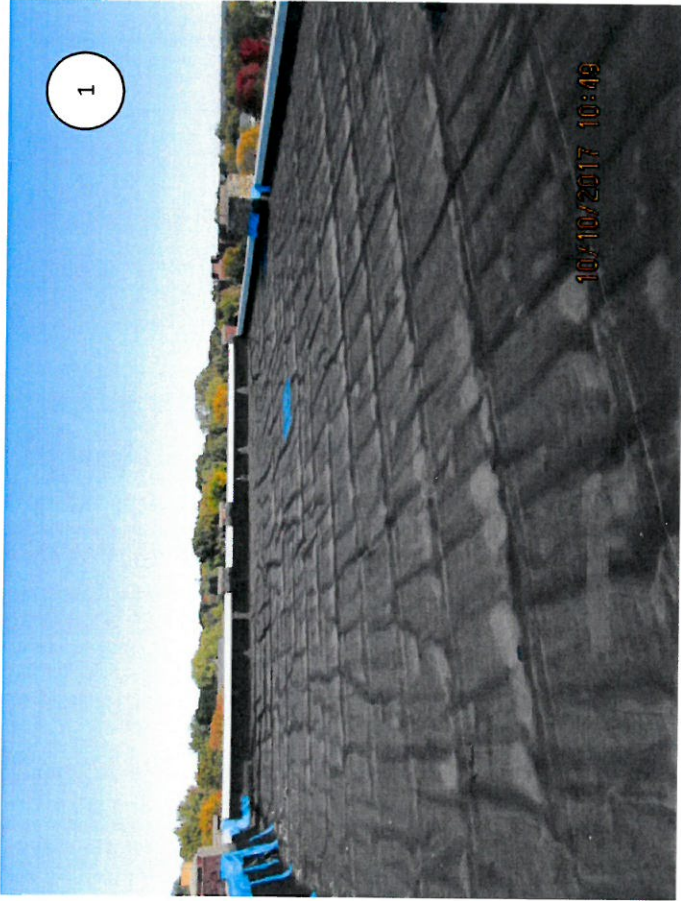
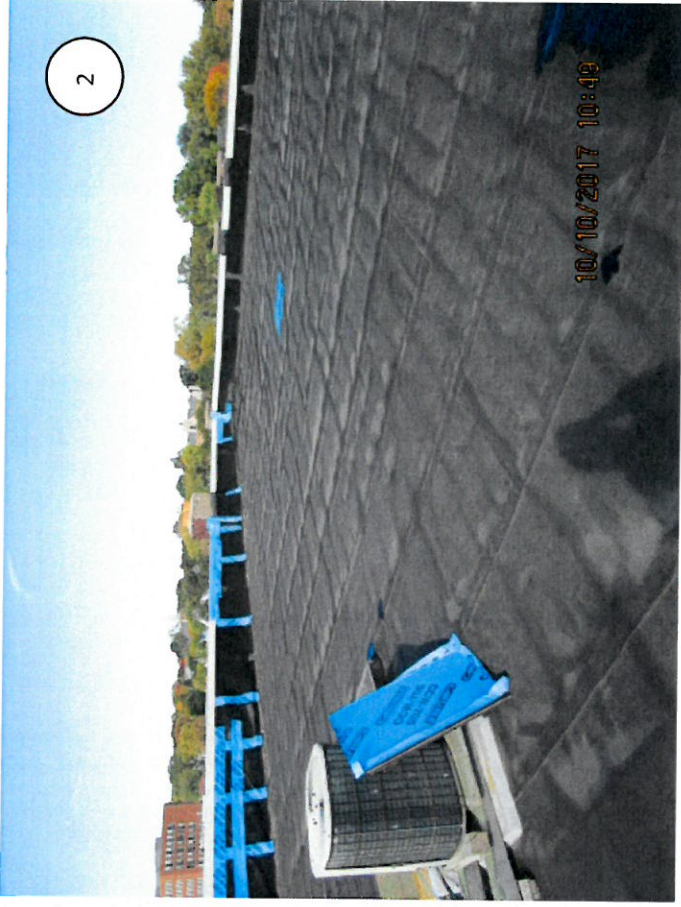
The roof system on main roof area on this facility is comprised of a smooth surface-single-ply modified cap sheet system over an OSB sheathing deck which covers the original wood plank deck (photos 1-2). Penetrations include various pipe penetrations and a roof hatch. Roof drainage is accomplished by a structurally sloped deck which slopes to the rear of the building with a gutter and downspout system which allows drainage away from the structure. To the rear of the structure is a fully adhered EPDM structurally sloped roof with a gutter and downspout system also (photo 3-4)

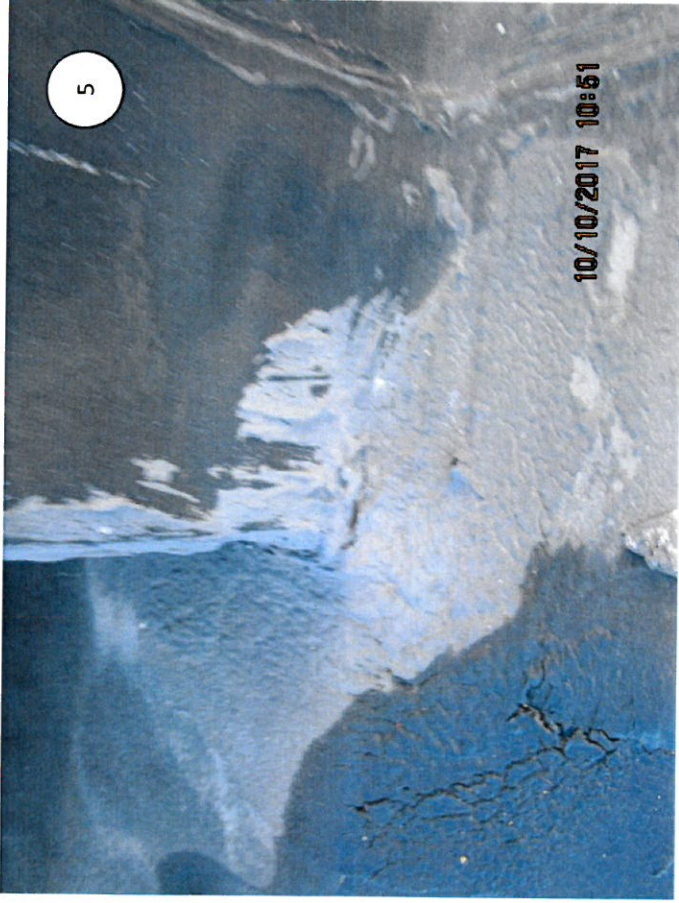
- Open base flashing laps observed at various locations (photo 5).
- Base flashing holes observed at various locations (photo 6).
- Improper termination of base flashing at the chimney and parapet locations (photo 7-8).
- Deteriorated sealant at flashing locations (photo 9).
- Opening along membrane seams (photo 10).

1. Repair all open base flashing laps with alternating layers of plastic cement and fabric. Approximately 40 feet of repair is recommended.
2. Repair all base flashing holes with alternating layers of plastic cement and fabric. Approximately 10 feet of repair is recommended.

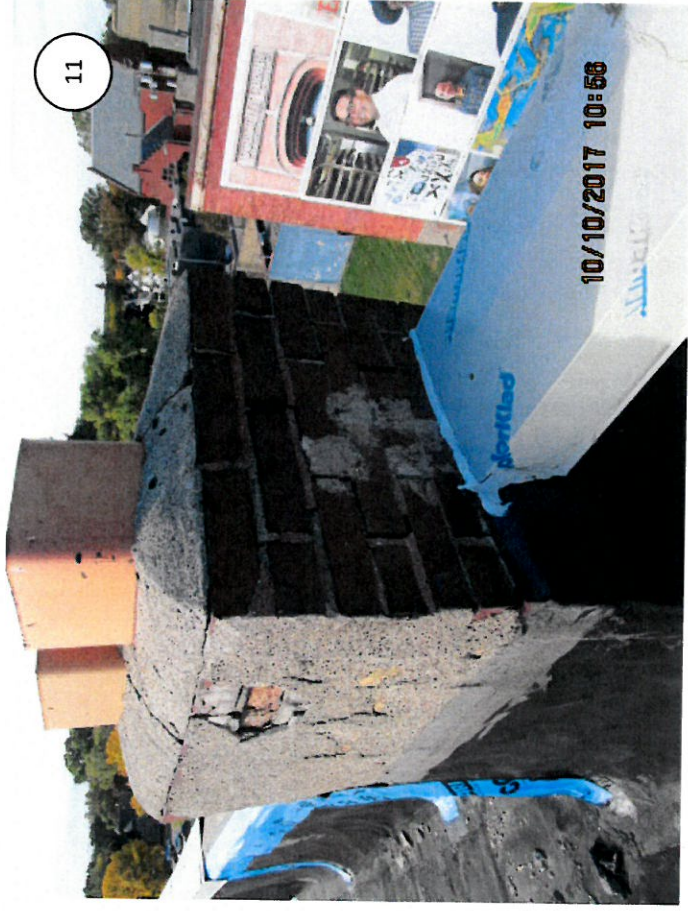
- Deteriorated brick and mortar issues at parapet and chimney locations (photo 11).
- Wrinkles in the membrane impeding drainage of water from the roof (photo 12).
- Holes in the roof membrane due to nails puncturing the membrane underneath or physical damage have left the membrane in extremely poor condition allowing water to infiltrate the structure in multiple locations (photos 13-18).
- Deteriorated rain cap over the heat exhaust stack (photo 19).

6. Monitor deteriorated brick and mortar at chimney and parapet locations for any leakage which may require repair prior reroofing.
7. Monitor wrinkles in the membrane for changes which may require repair prior to reroofing. Replace the membrane at the front of the building where the membrane has kinked and does not allow water to drain.
