Phase I Environmental Site Assessment

Former Speedway Gas Station
3744 Chicago Avenue South
Minneapolis, Minnesota

Project B2208959

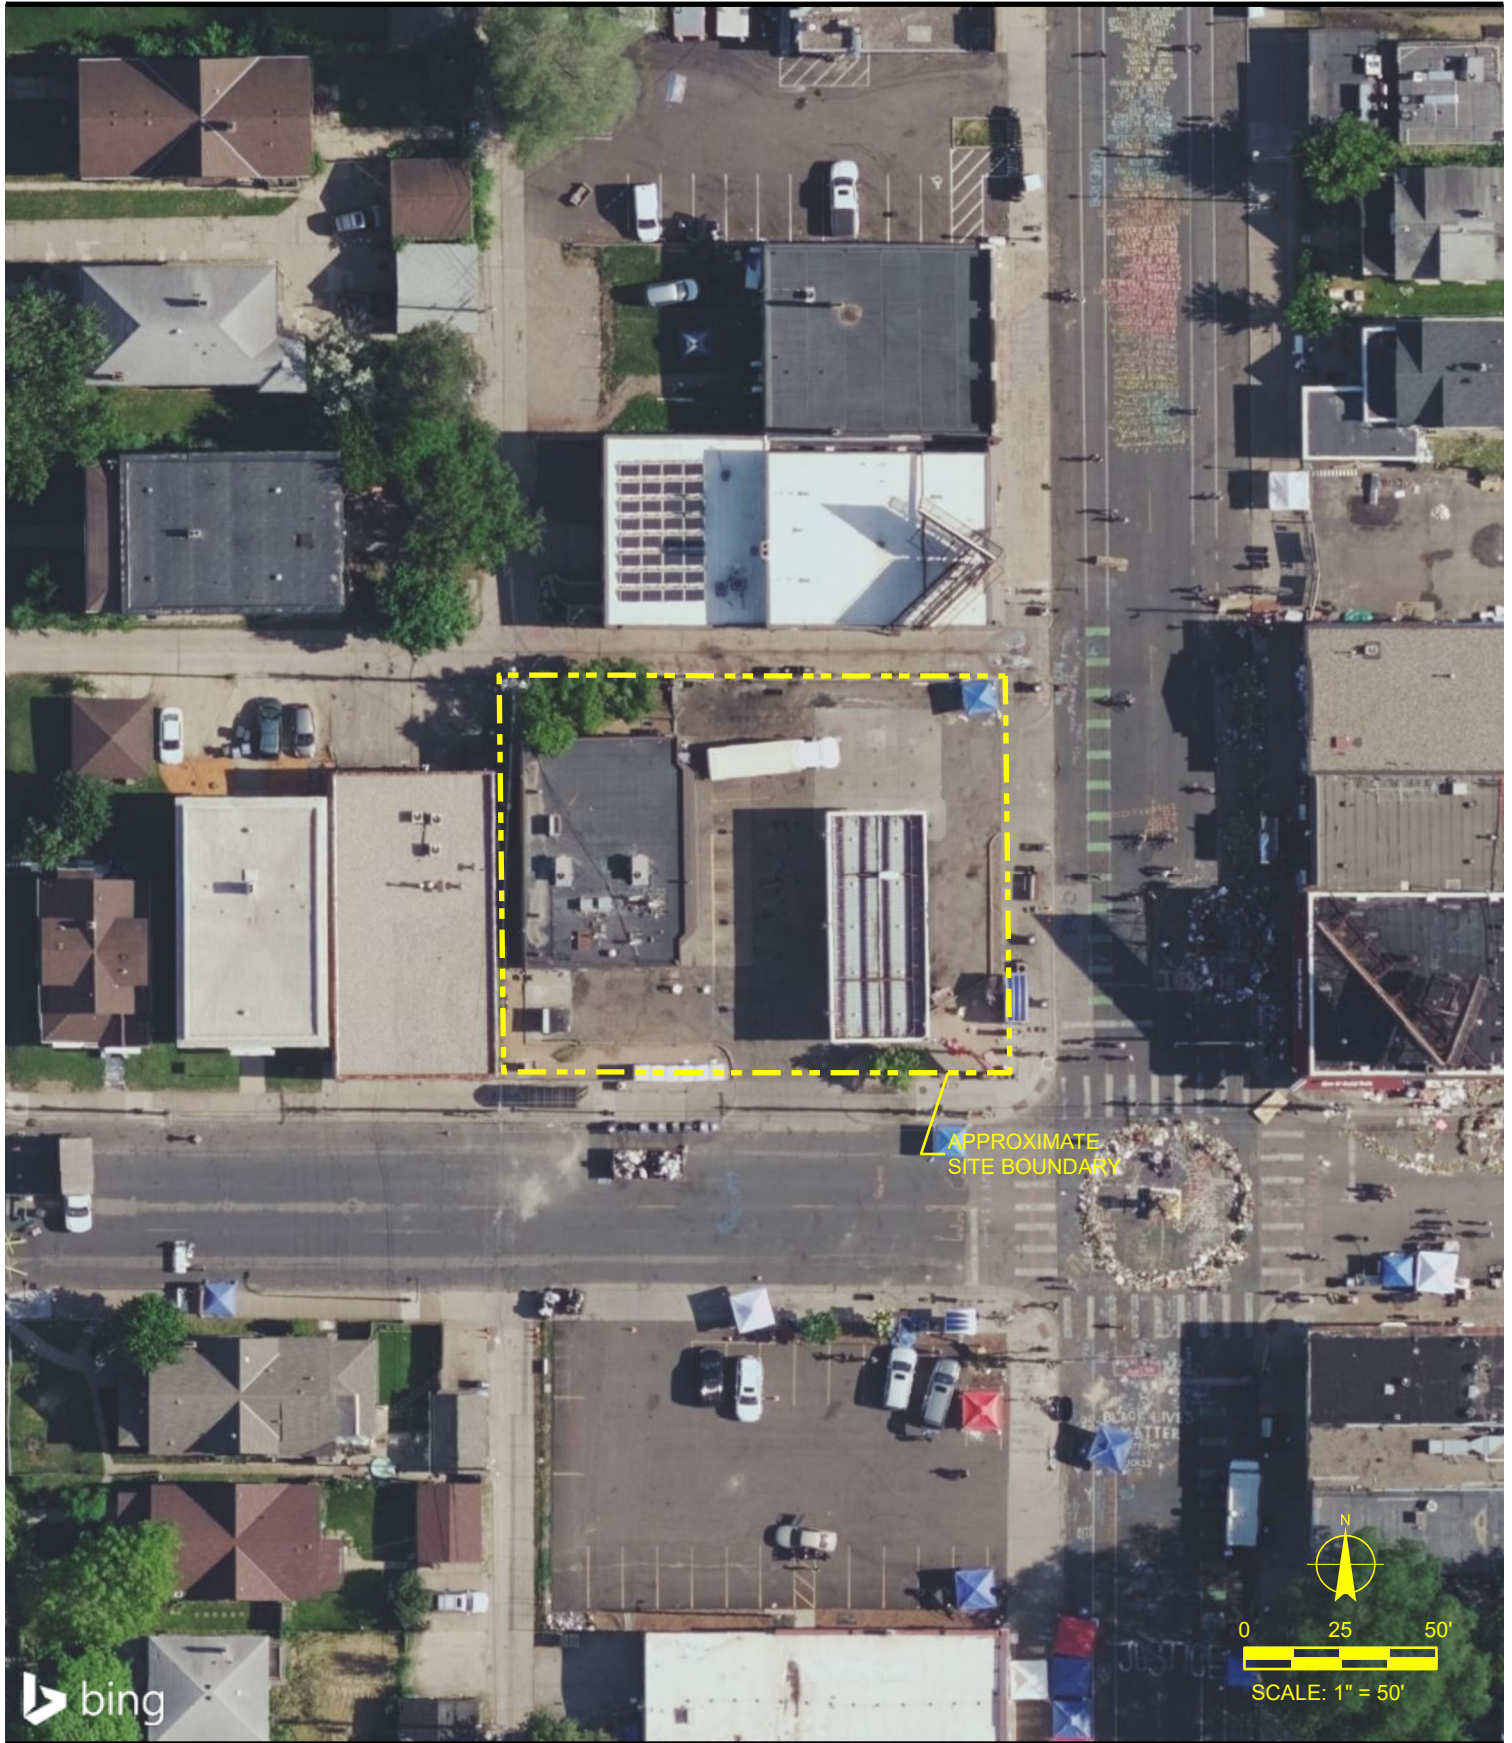
Figure 1

Site Location Map
