NPDES MS4 Phase I Permit No. MN0061018 Annual Report for 2019 Activities

City of Minneapolis and the Minneapolis Park & Recreation Board
Co-Permittees

June 30, 2020

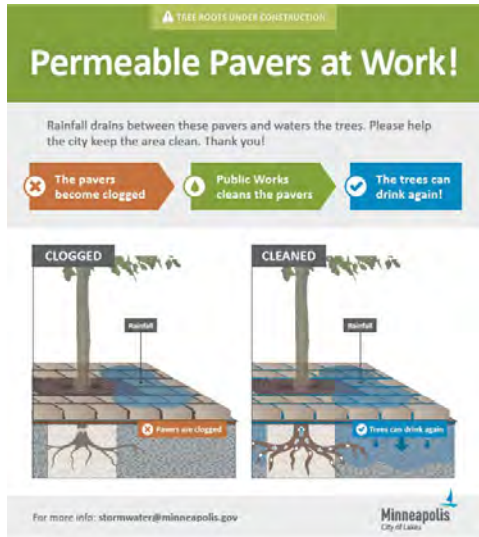
In 2019, the pervious pavers along 2nd and Marquette Avenues required maintenance to restore their effectiveness. This maintenance project provided an educational outreach opportunity for city staff. Staff distributed notice of construction letters to property owners with construction details, and

information on how these permeable pavers support boulevard trees and assist in stormwater management. Informational flyers were also available. Following the maintenance project interpretive signs were installed at several paver locations. These interpretive signs inform people how pavers work and why restoration of them maintains their functionality.

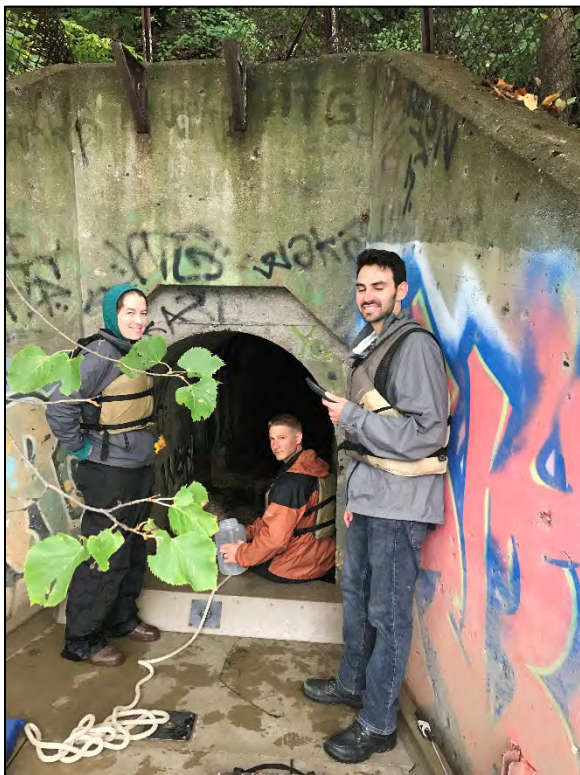
Minneapolis Public Works staff conducting a field dry weather flow screening

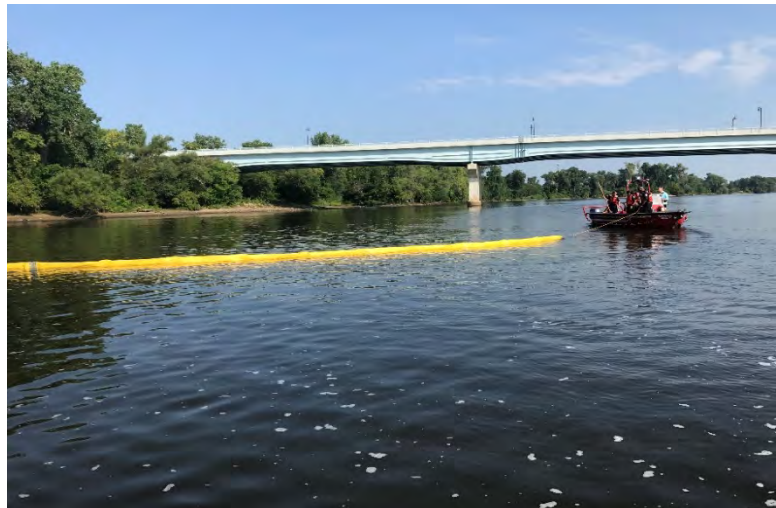
Minneapolis Regulatory Services utilizes a boat to respond to spills that could impact water resources. A properly equipped boat facilitates addressing these events on the Mississippi River as well as on City lakes. Regulatory Services and Public Works staff are trained in the river deployment of booms, have field experience in placement of both containment and absorbent types of booms, and years of experience on the water. These skills, coupled with an extensive level of knowledge of the Mississippi River, City lakes, landings, and outfalls, provide a high level of protection for our precious natural resources.

Boom Deployment Drill

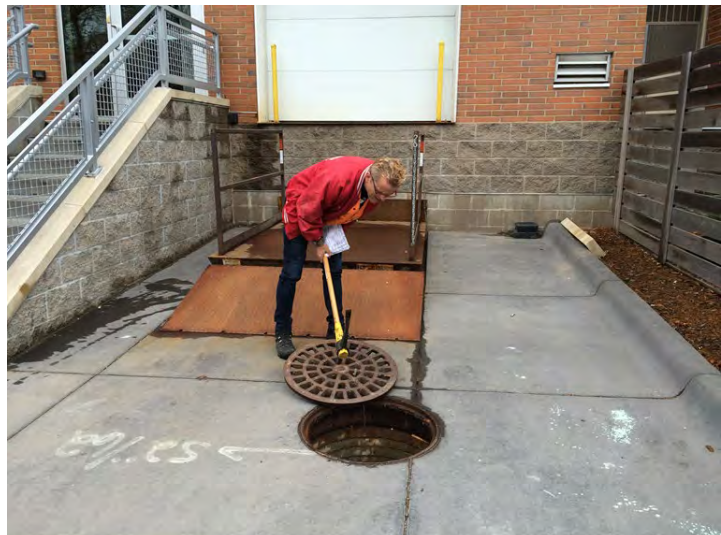
These plans are reviewed through the Minneapolis Development Review process and approved by the Surface Water & Sewers Division. Operation and Maintenance Plans for BMPs are also required as part of the approval process. Inspections of constructed BMPs are

required and performed by the property owner or manager. These annual inspections are reviewed and approved by city staff, before being registered with Environmental Services, which includes a Pollution Control Annual Registration fee.

Inspecting Private Stormwater BMPs

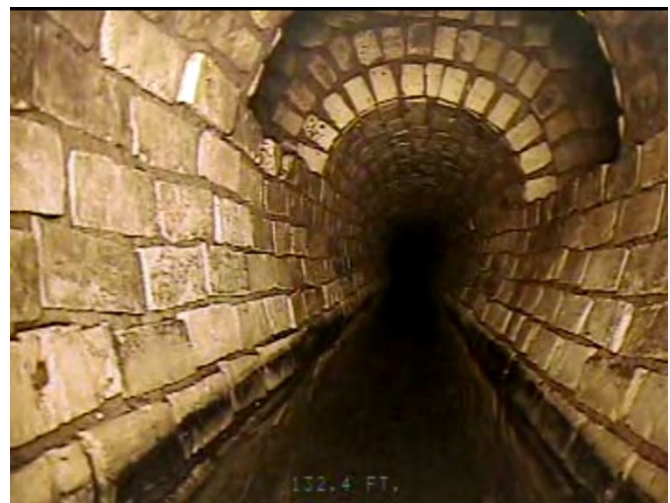
Brick Egg-type Sewer

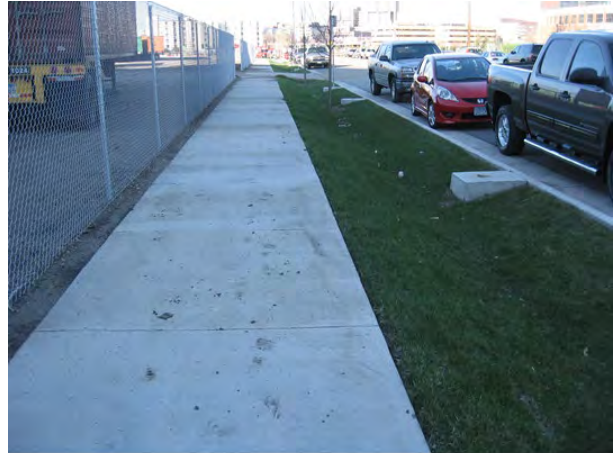
Vegetated Swale at 25th Ave. SE

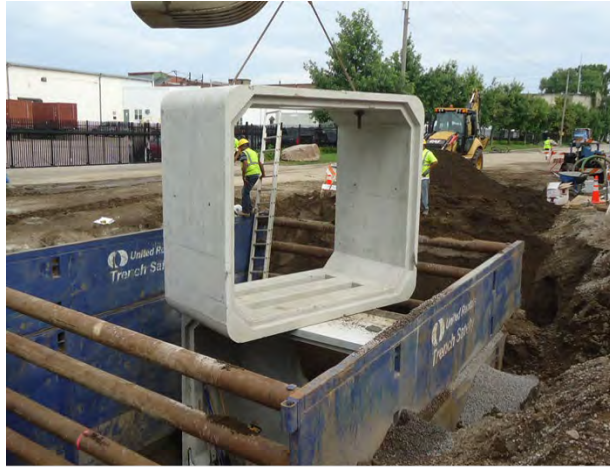
12x10 Infiltration Box Culvert Installation

Infiltration BMPs treat urban stormwater runoff as it flows through a filtering medium and into underlying soil, where water percolates down into groundwater. This process removes pollutants from

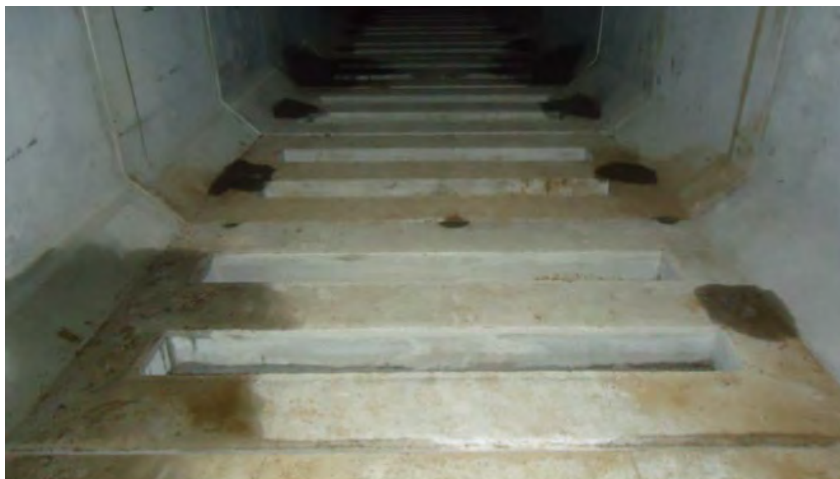
Infiltration Box Culvert – inside view

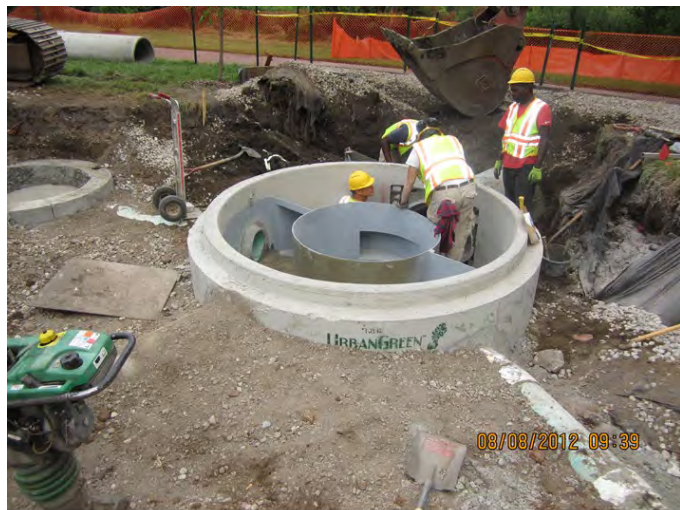
Grit Chamber Construction at Dean Pkwy

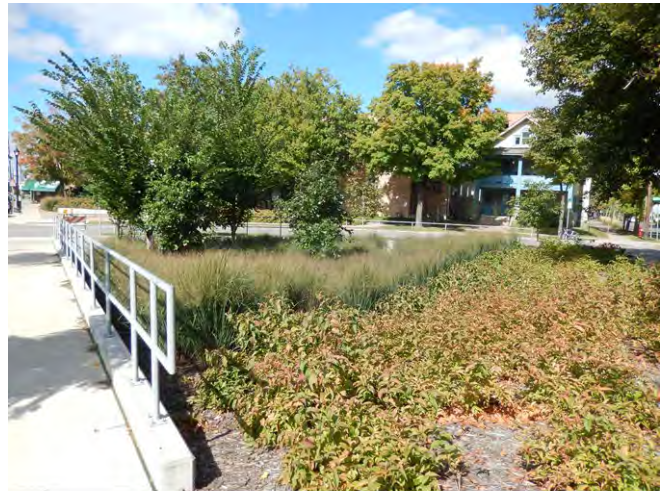
Rain Garden at Riverside and 8th St. S

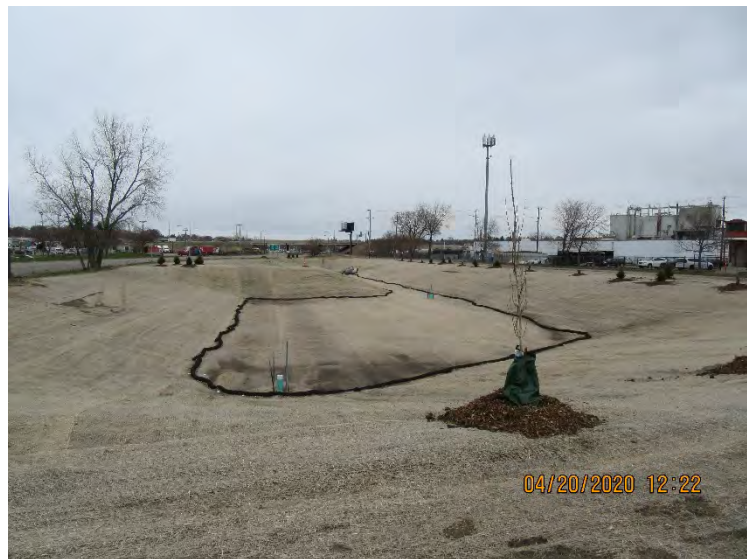
As part of the Mid-City Industrial street reconstruction project, an infiltration (dry) pond was constructed adjacent to New Brighton Blvd. This location in Minneapolis had a history of street and property flooding based on complaints received from area businesses. The primary reasons for the flooding were surcharging of the storm drain network due to lack of capacity in the pipes and large areas of impervious surface flowing into the storm drain system without attenuation.

The street reconstruction provided the opportunity to replace the affected systems with larger pipes. However, the storm tunnel that receives discharge from the project area is not able to handle the resulting increase in flows. Therefore, a regional storage basin was required to offset the increase in flows. In addition to providing flood mitigation, the pond will also provide water quality treatment by allowing for the infiltration of stormwater into the underlying soils.

- MIDS volume reduction
 - 53% (30.4 acre-feet infiltrated)
- MIDS total phosphorus removal
 - 53% (24.8 pounds removed)
- MIDS total suspended solids removal
 - 53% (4,510 pounds removed)

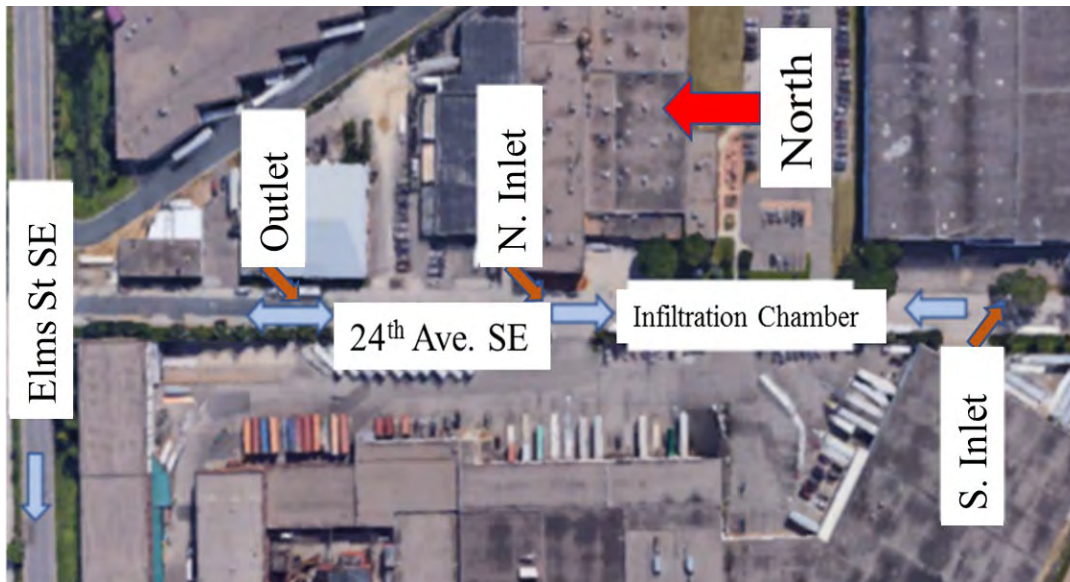
Figure 23-2. Aerial photo of 24th & Elm Infiltration Chamber and its inlets and outlet. Blue arrows show the direction of flow. Only the inlets were monitored for FOG.

Figure 23-1 shows the location of the four representative land use sites and their location within the City of Minneapolis, MN. **Figure 23-2** show the location of the 24th and Elm infiltration basin north and south inlets, and **Figure 23-3** shows the Winter Infiltration Basin south and west inlets.

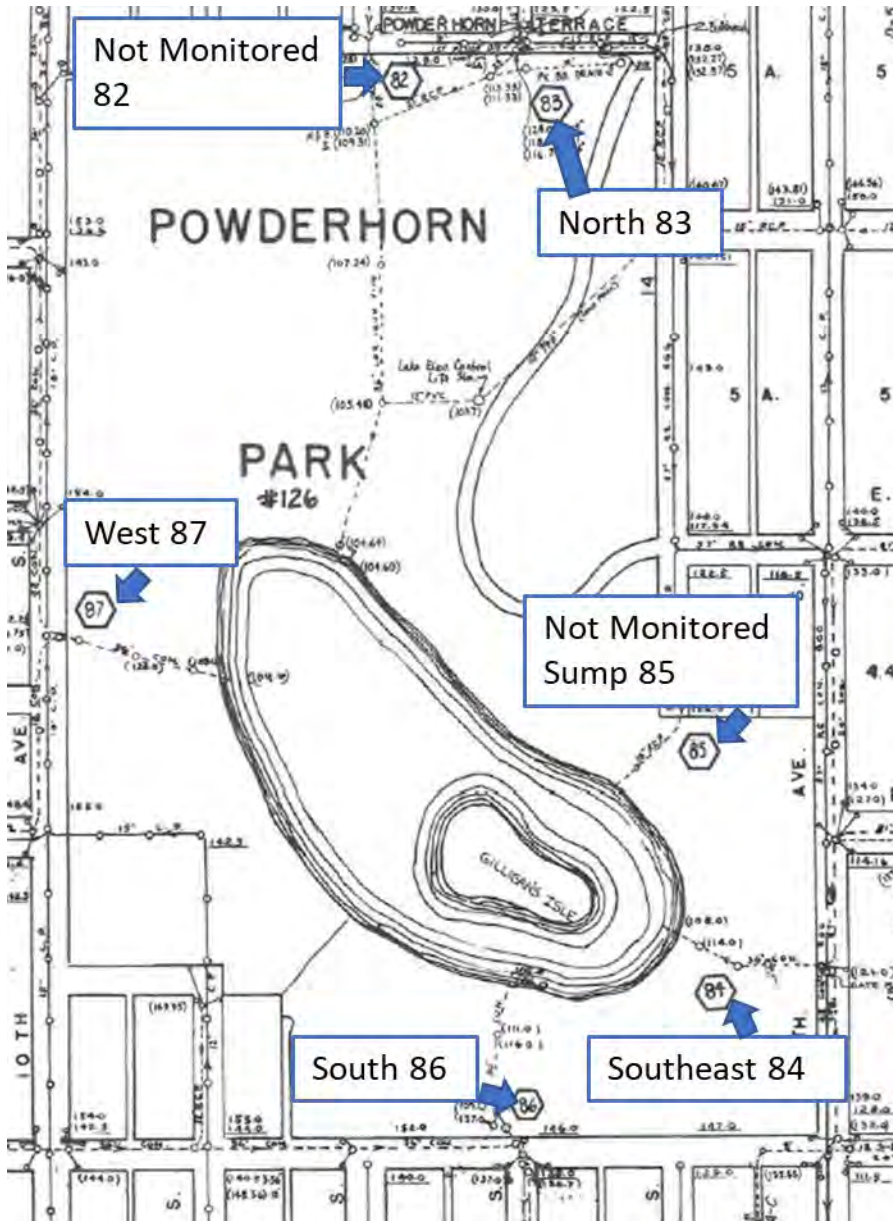
Figure 24-3. Storm sewer map of CDS grit chambers 82-87 surrounding Powderhorn Park.

There are five CDS grit chambers, and one sump structure installed in stormwater pipes leading to Powderhorn Lake. A sump is a pit, usually in a catch basin, that settles out solids. **Table 24.1** shows the Powderhorn CDS grit chamber assigned numbers, location, and drainage areas for each CDS unit. CDS unit 82 was not monitored since it is adjacent to and has an almost identical watershed to CDS unit 83. Sump 85 was not monitored because the watershed was very small (3.1 acres) which is about 1% of the watershed.

The Powderhorn Lake watersheds are shown in **Figure 24-2**. In 2001, five CDS grit chambers were installed at the outlets to the larger watersheds flowing to Powderhorn Lake in order to remove solids from stormwater inflow **Figure 24-3**.

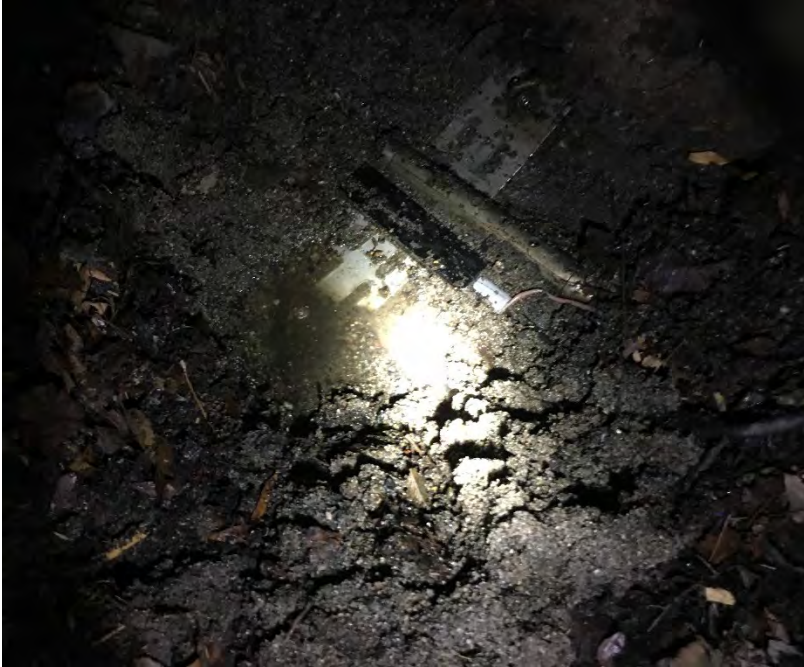
Figure 24-7. 2019 Powderhorn Inlet South offset AV probe and intake strainer after removing 8” of sand and debris.

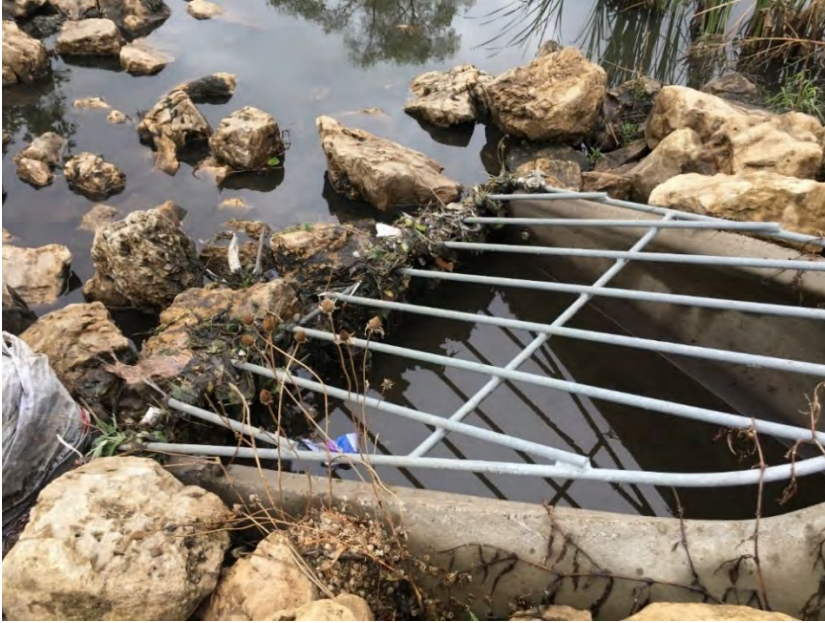
Figure 27-2. Photo of the south 24” inlet flared-end outfall and trash building up on the inside of the grate.

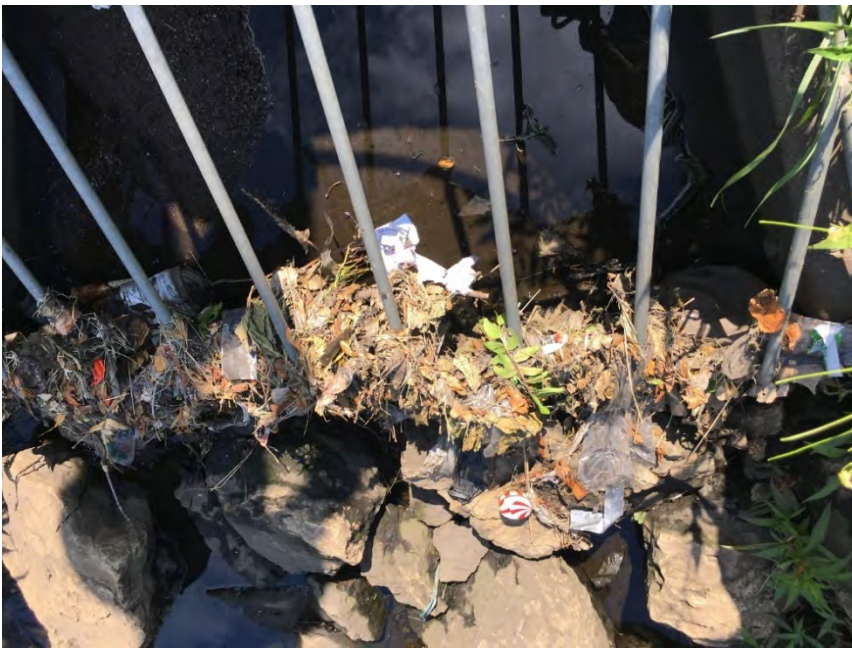
Figure 27-3. Looking upstream, a closer photo of the south inlet and trash building up on the inside of the grate.

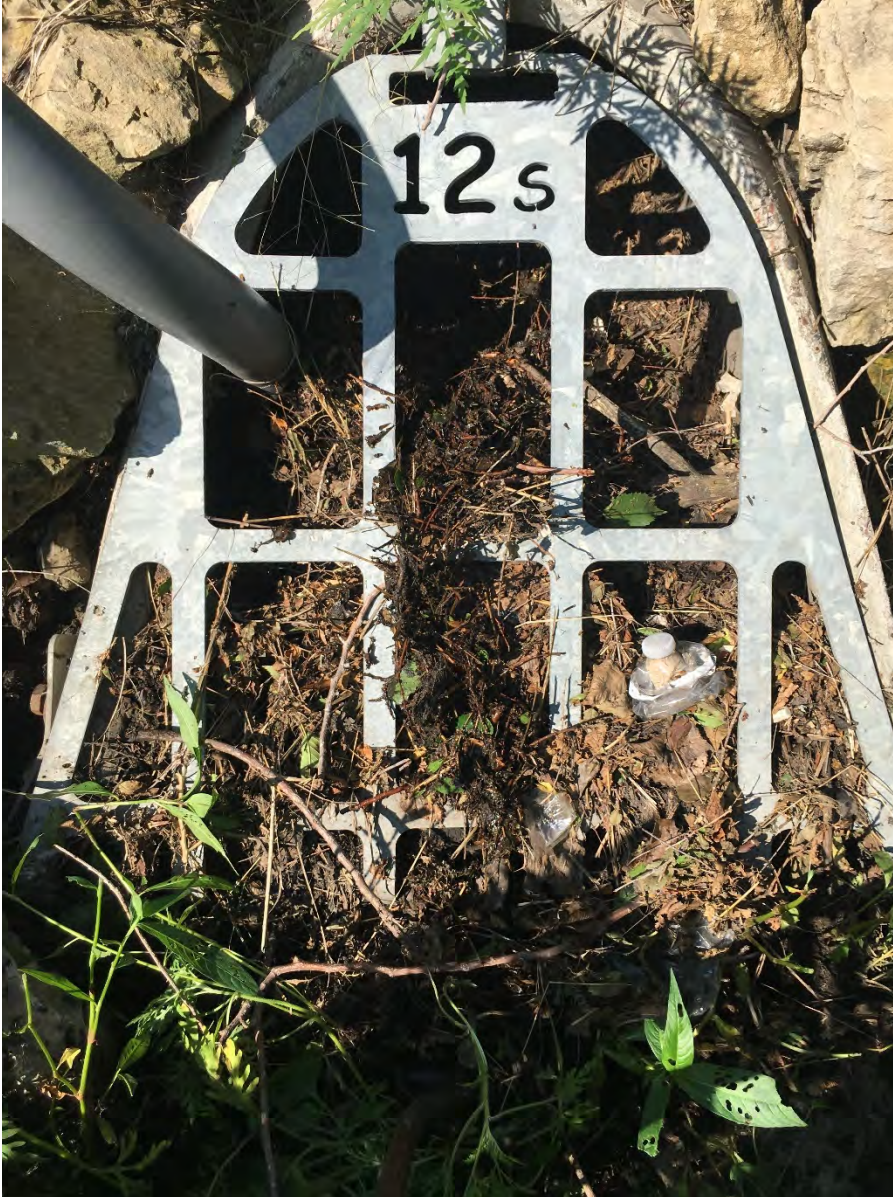
Figure 27-4. Photo of the west 12” inlet flared-end outfall and debris building up on the inside of the grate.

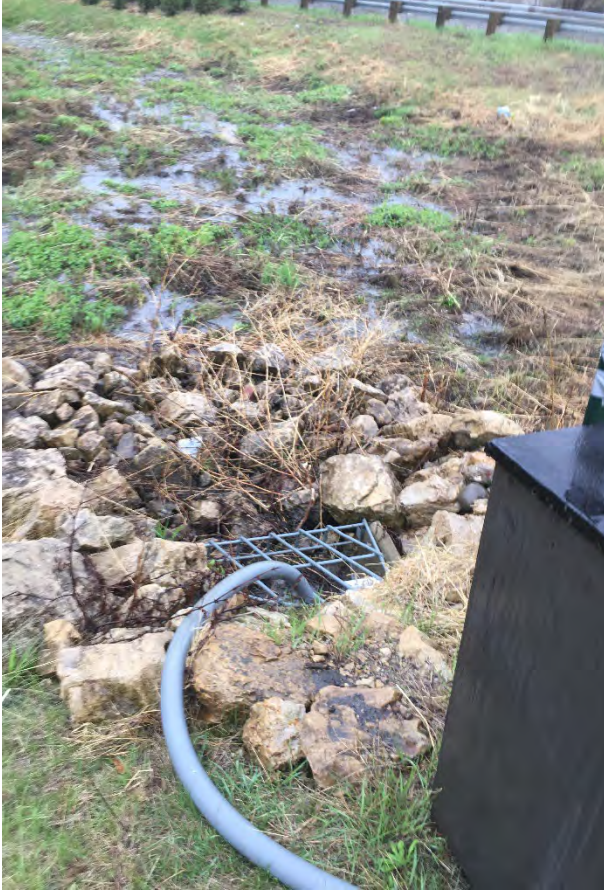
Figure 27-5. Photo of the WIB outlet. Standing water can be seen in the basin waiting to infiltrate and it has not reached the outlet. The brown box contains the monitoring equipment and the gray conduit armors the AV cable and sampler pump tubing.

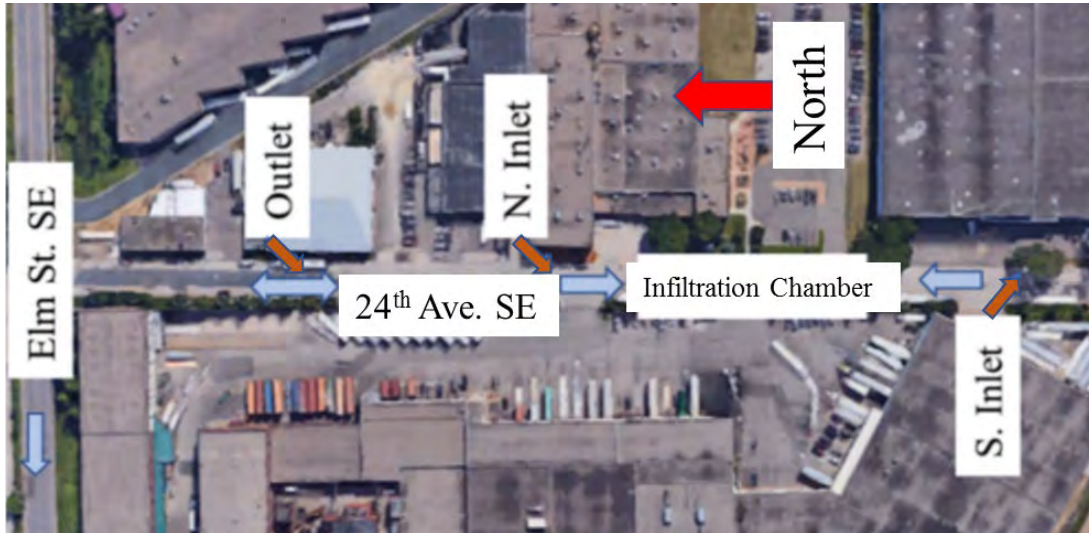
Figure 26-1. Aerial photo of 24th & Elm Infiltration Chamber and its inlets and outlet. Blue arrows show the direction of flow.

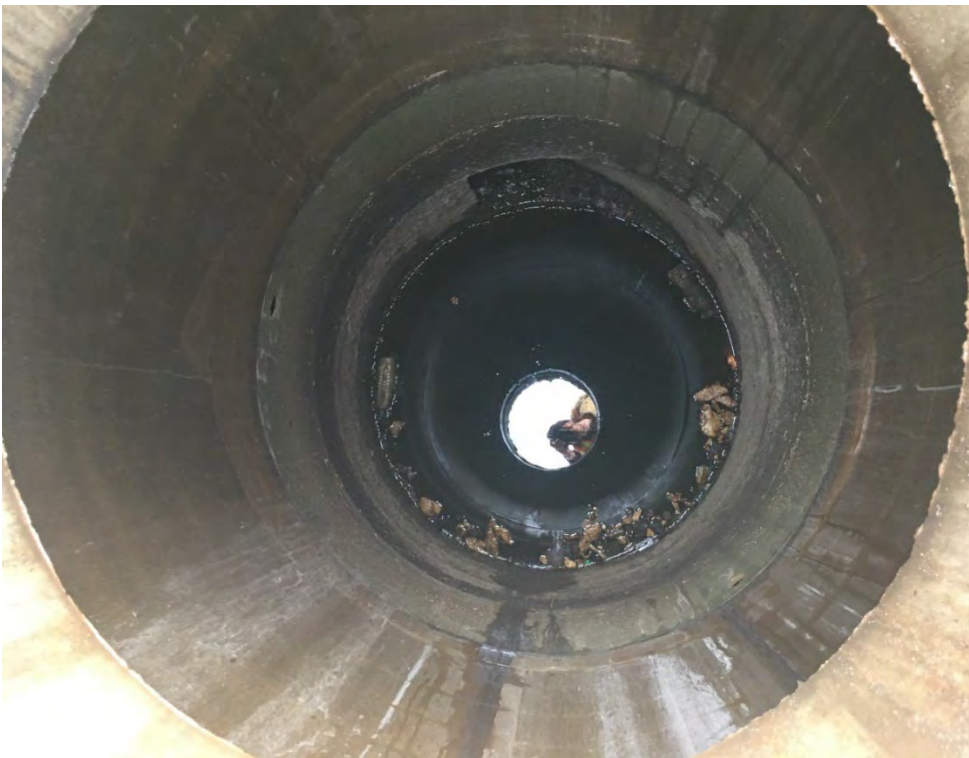
Figure 26-3. Photograph of the top clean-out manhole access of the north Contech hydrodynamic CDS separator.

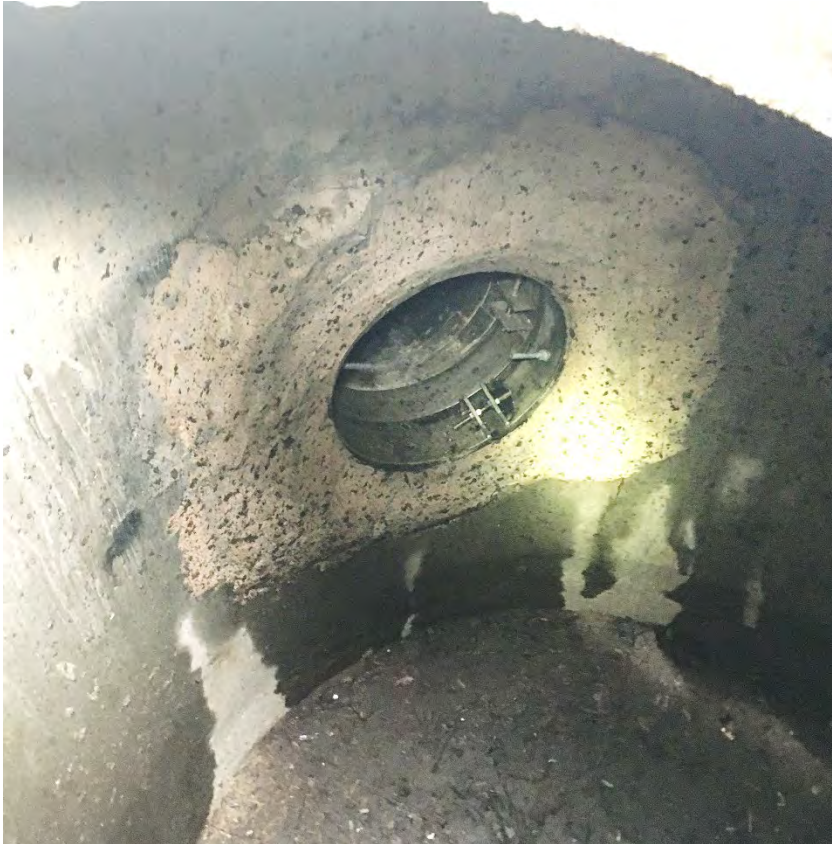
Figure 26-4. Photograph of the backflow preventer at 24th Ave. SE, and Elm St. SE. The backflow preventer is approximately 36” above the 24th pipe invert.

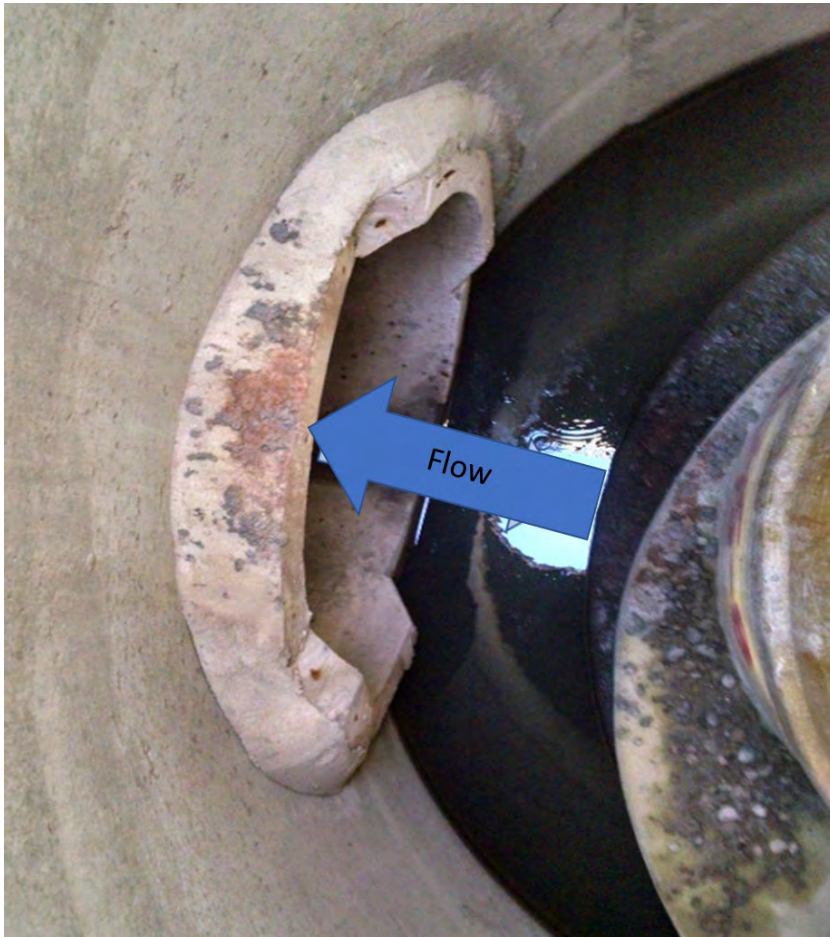
Figure 26-5. Photograph of the 36-inch north inlet at 24th & Elm prior to equipment installation. Note the hydrodynamic separator upstream on the right. The blue arrow shows the direction of flow. Note, part of the pipe had to be cut away to allow access.

The north inlet was installed on 5/2/19. On 5/10/19, the south inlet and outlet monitoring equipment were installed. Both inlets were installed downstream of the hydrodynamic separators. Access to the inlets at 24th & Elm was very cramped to work in and part of the north inlet pipe had to be removed to facilitate access, **Figure 26-5**. All equipment was removed on 11/1/19.

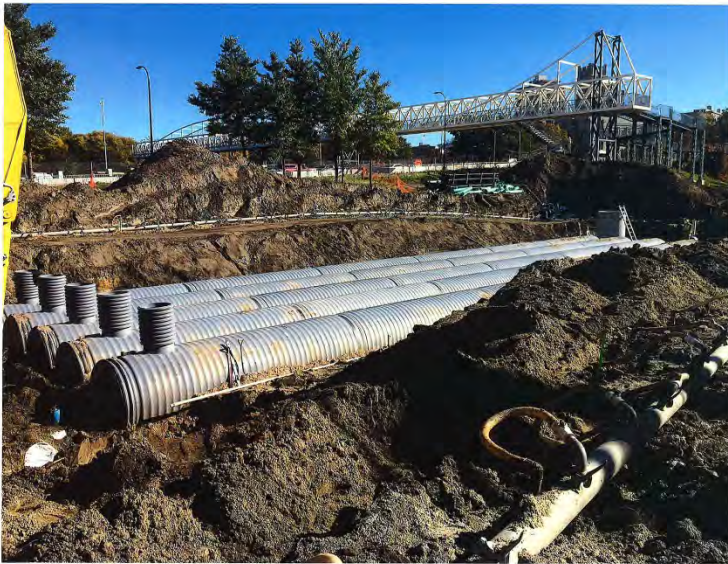
Figure 25-2. Photograph of the 80,000-gallon underground cistern under construction.

In June 2017 the Minneapolis Sculpture Garden finished construction of an 80,000-gallon underground cistern. The purpose of the cistern is to collect overflow water from three areas: the Spoonbridge and Cherry sculpture, runoff from the southern 2/3rds of the garden paths, and runoff from a portion of Parade Field for reuse in irrigation at the Sculpture Garden. **Figure 25-1** shows construction plans for the Minneapolis Sculpture Garden and the location of the underground stormwater runoff storage cistern. **Figure 25-2** shows the underground cistern chambers during construction prior to their burial. **Figure 25-3** shows the north manhole used to sample the cistern.

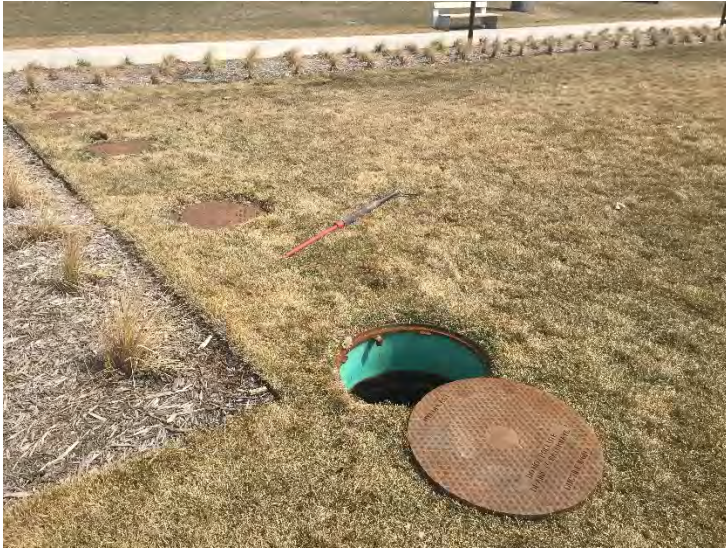
Figure 25-3. Photograph of the north manhole where sampling occurred at the underground cistern.

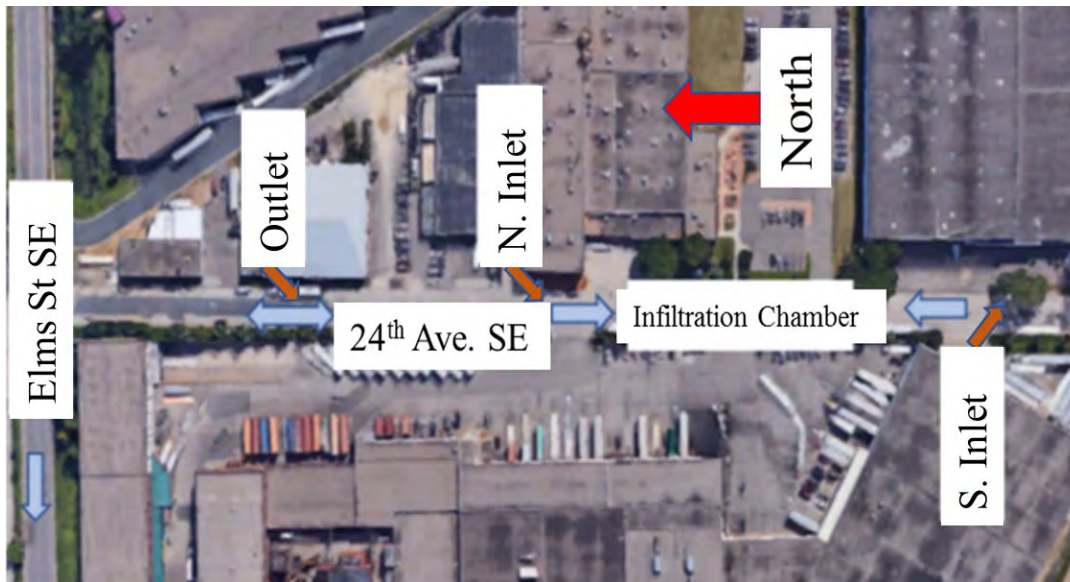
Figure 23-2. Aerial photo of 24th & Elm Infiltration Chamber and its inlets and outlet. Blue arrows show the direction of flow. Only the inlets were monitored for FOG.

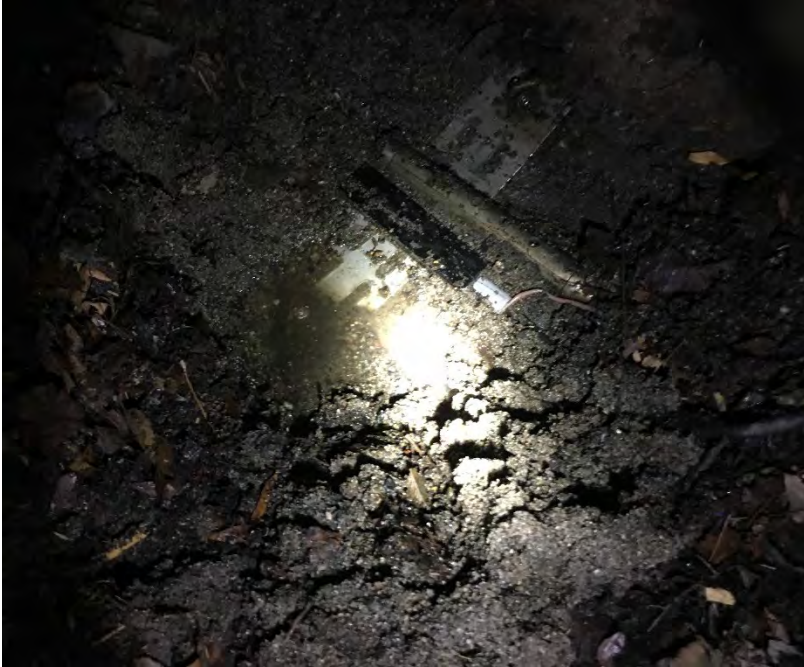
Figure 24-7. 2019 Powderhorn Inlet South offset AV probe and intake strainer after removing 8” of sand and debris.

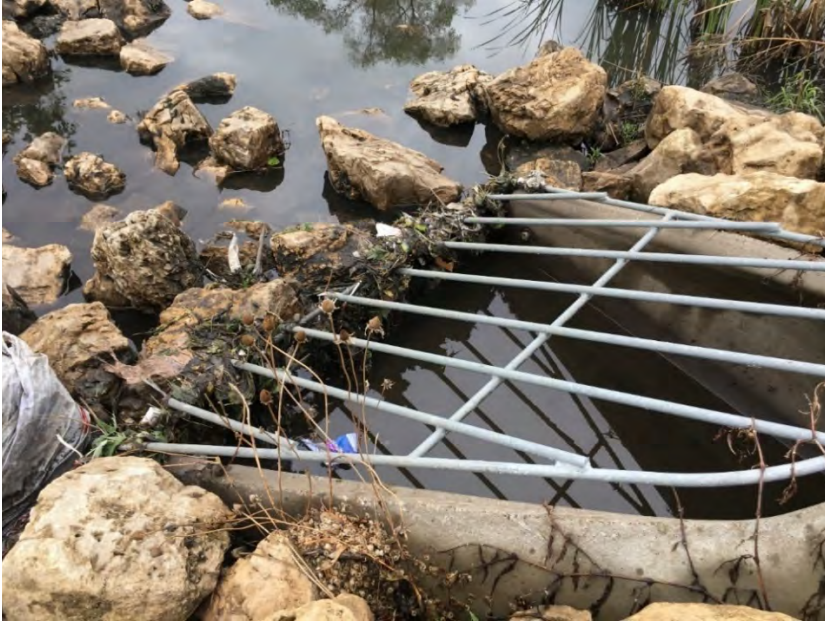
Figure 27-2. Photo of the south 24” inlet flared-end outfall and trash building up on the inside of the grate.

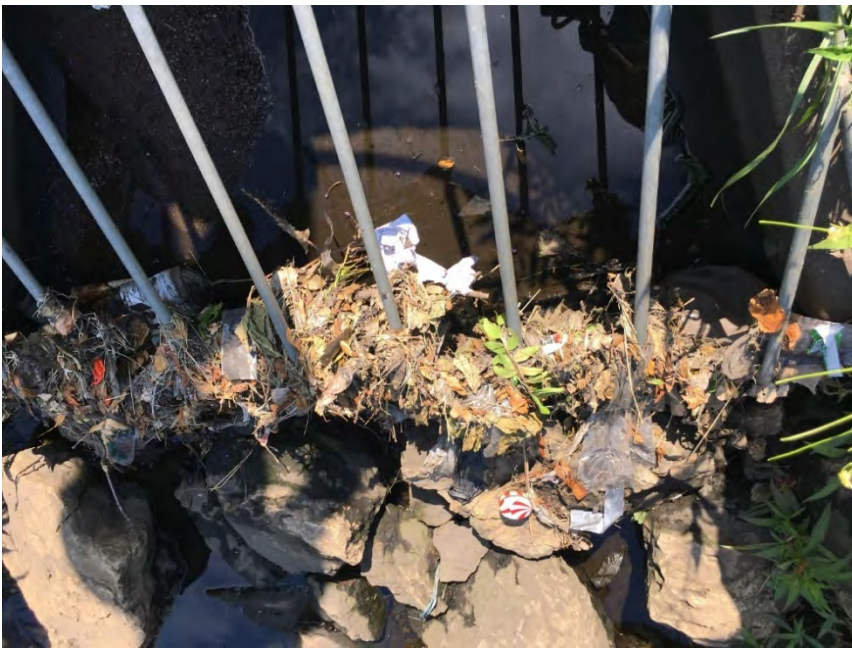
Figure 27-3. Looking upstream, a closer photo of the south inlet and trash building up on the inside of the grate.

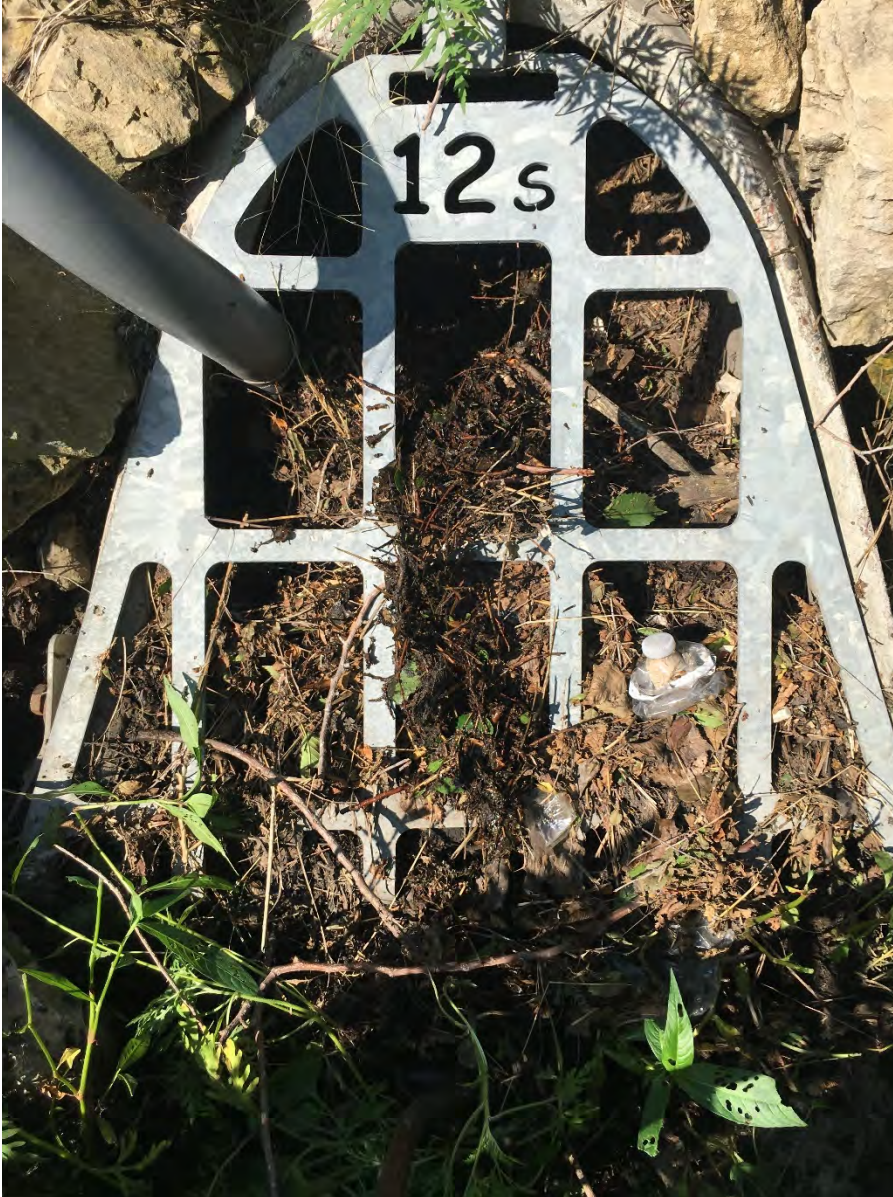
Figure 27-4. Photo of the west 12” inlet flared-end outfall and debris building up on the inside of the grate.

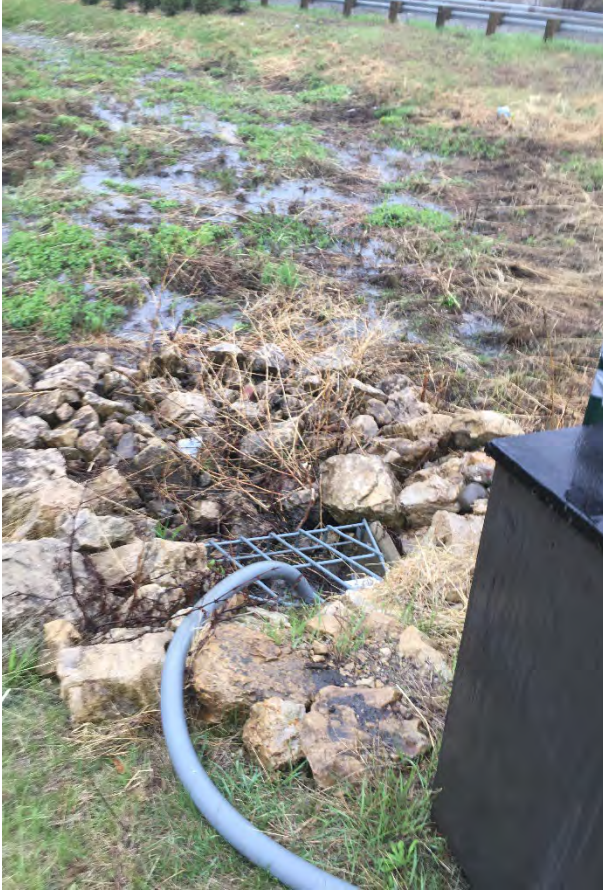
Figure 27-5. Photo of the WIB outlet. Standing water can be seen in the basin waiting to infiltrate and it has not reached the outlet. The brown box contains the monitoring equipment and the gray conduit armors the AV cable and sampler pump tubing.

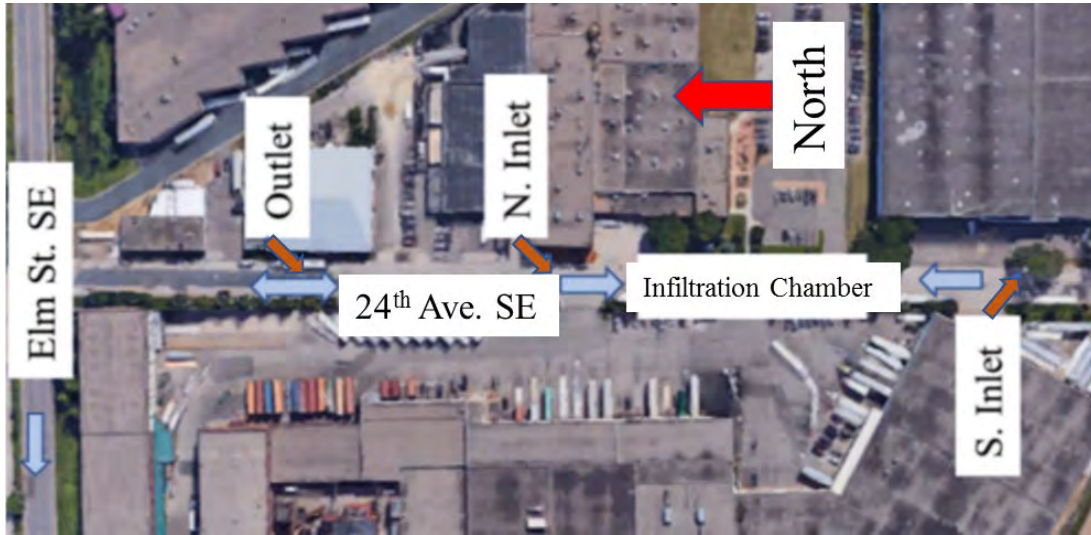
Figure 26-1. Aerial photo of 24th & Elm Infiltration Chamber and its inlets and outlet. Blue arrows show the direction of flow.

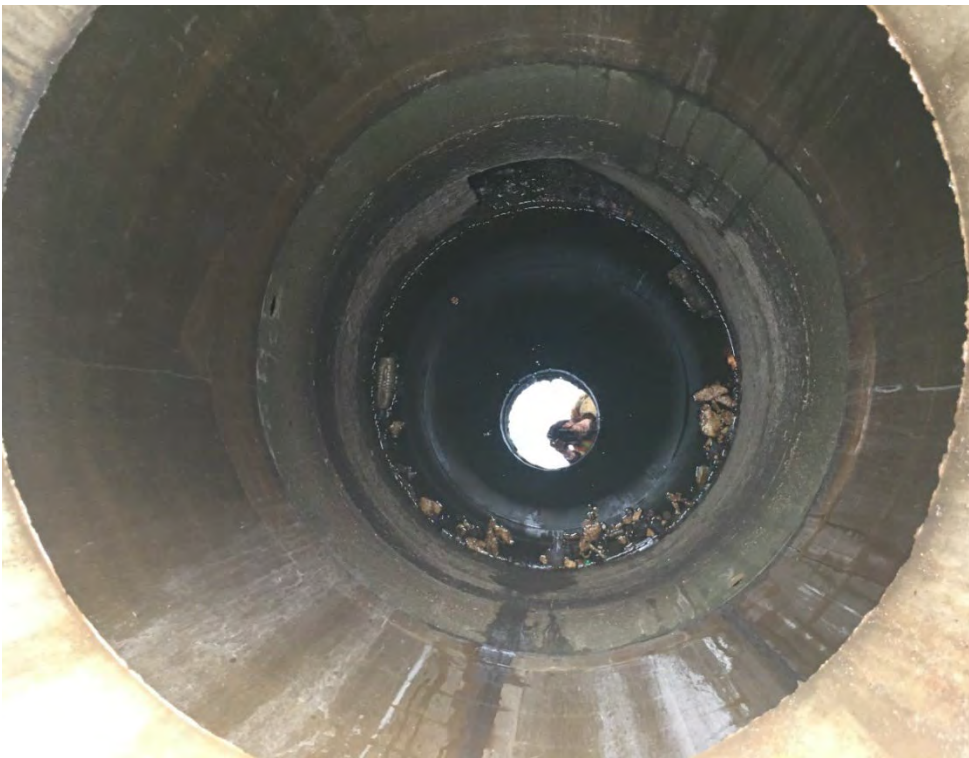
Figure 26-3. Photograph of the top clean-out manhole access of the north Contech hydrodynamic CDS separator.

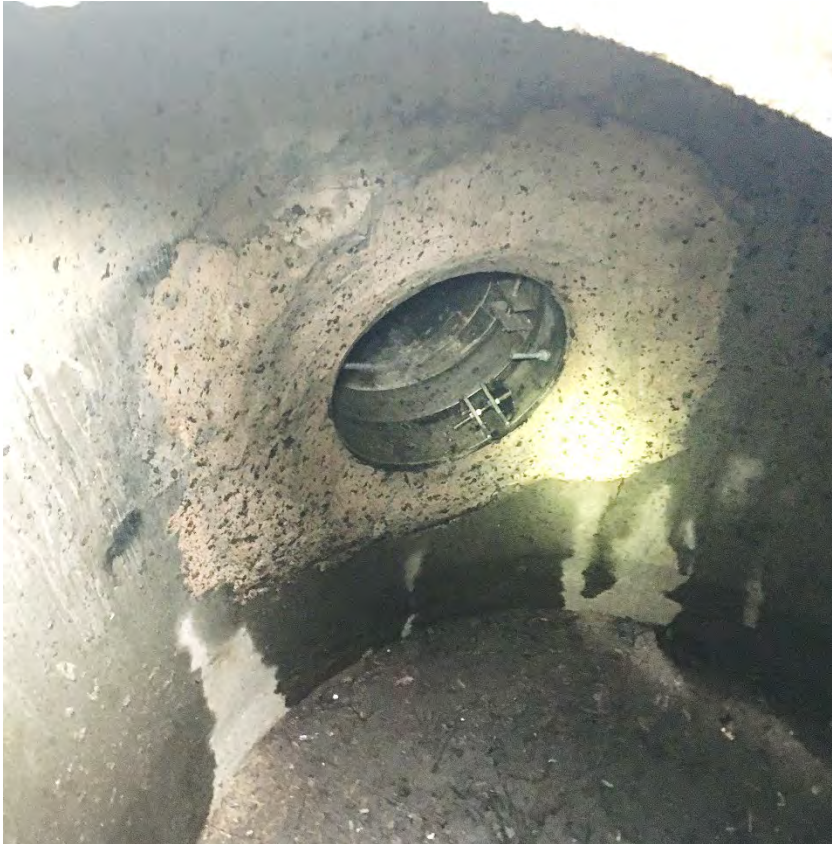
Figure 26-4. Photograph of the backflow preventer at 24th Ave. SE, and Elm St. SE. The backflow preventer is approximately 36” above the 24th pipe invert.

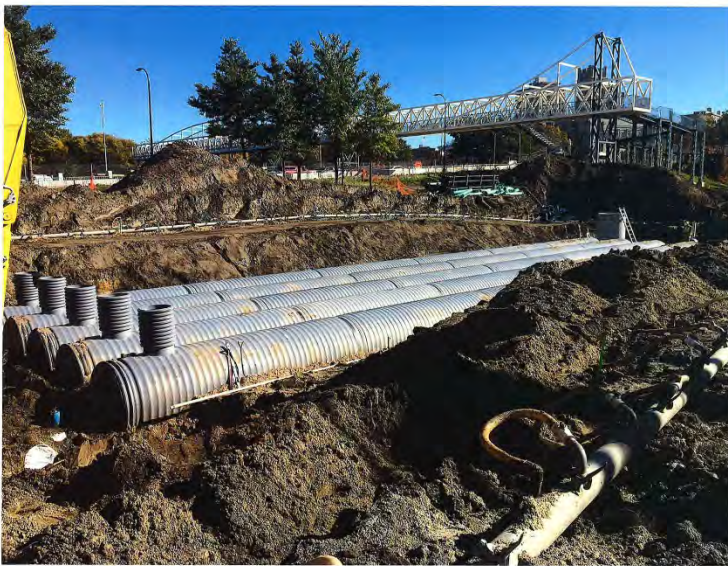
Figure 25-2. Photograph of the 80,000-gallon underground cistern under construction.

In June 2017 the Minneapolis Sculpture Garden finished construction of an 80,000-gallon underground cistern. The purpose of the cistern is to collect overflow water from three areas: the Spoonbridge and Cherry sculpture, runoff from the southern 2/3rds of the garden paths, and runoff from a portion of Parade Field for reuse in irrigation at the Sculpture Garden. **Figure 25-1** shows construction plans for the Minneapolis Sculpture Garden and the location of the underground stormwater runoff storage cistern. **Figure 25-2** shows the underground cistern chambers during construction prior to their burial. **Figure 25-3** shows the north manhole used to sample the cistern.
