Barriers to Walking for Public Housing Highrise Residents

Findings from 2014 Listening
Sessions and Walking Audits

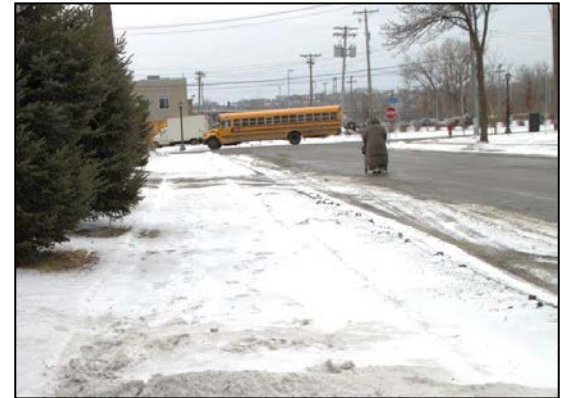
A resident using a walker walks in the street to avoid an unshoveled sidewalk on Dupont Ave N near Heritage Commons at Pond's Edge

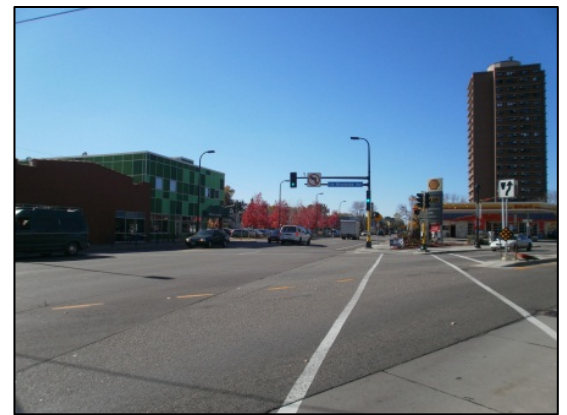
E Franklin Ave & Riverside Ave: Traffic signal with green arrow for right turns is confusing for crossing pedestrians; the wide intersection is also intimidating.

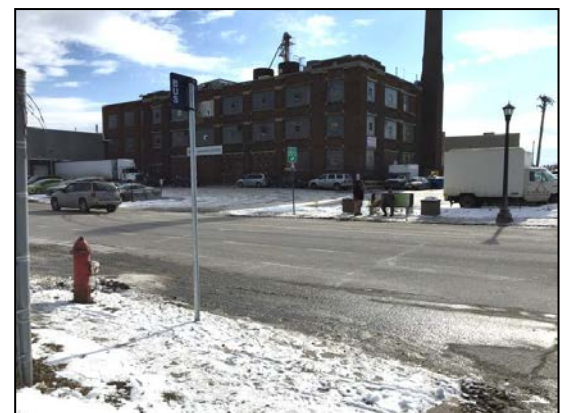
Dupont Ave N and Glenwood Ave N: Traffic traveling on Glenwood Ave N does not have a stop sign, and residents find it difficult to cross the street to get to the bus stop.

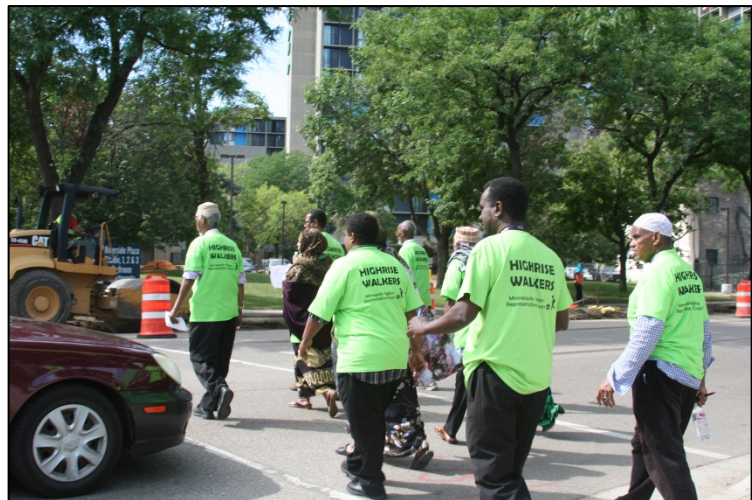
Residents of the Cedars find the high traffic volumes near their highrise to be uncomfortable

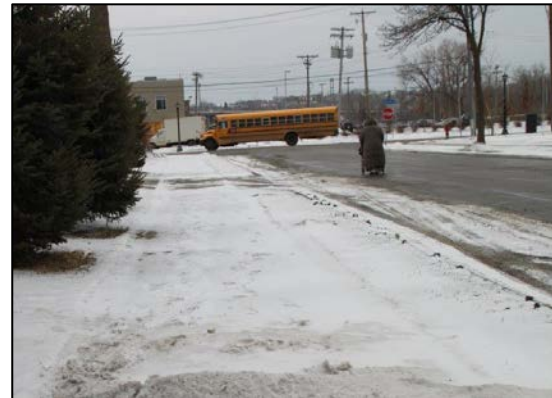
A resident using a walker walks in the street to avoid an unshoveled sidewalk on Dupont Ave N near Heritage Commons at Pond's Edge

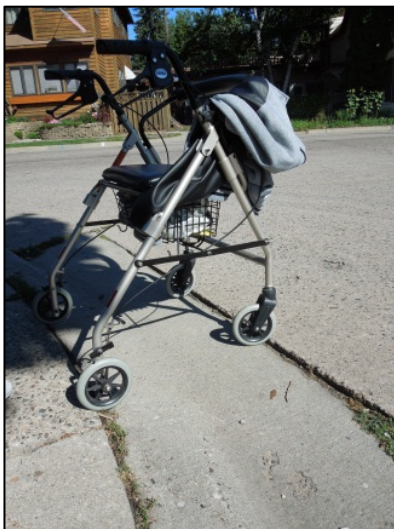
18th Ave NE & NE Polk St: A gutter pan sunk below street level catches the wheels on a resident's walker

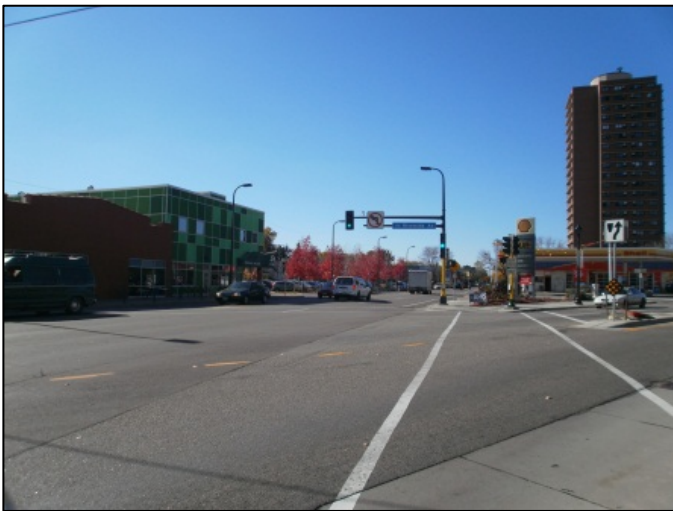
E Franklin Ave & Riverside Ave: Traffic signal with green arrow for right turns is confusing for crossing pedestrians; the wide intersection is also intimidating.

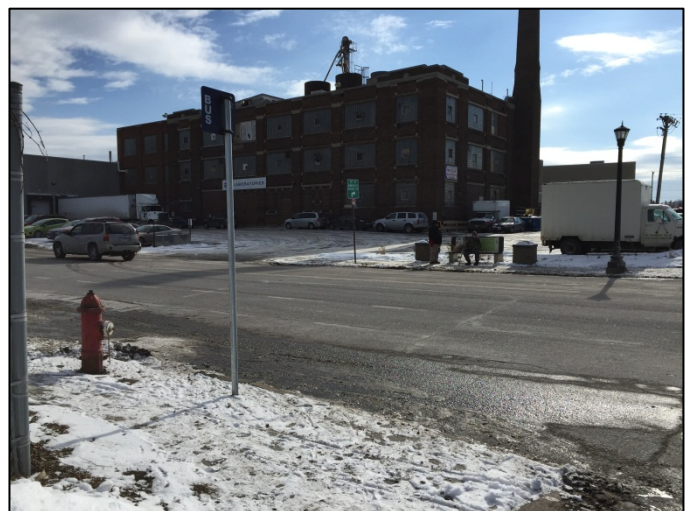
Dupont Ave N and Glenwood Ave N: Traffic traveling on Glenwood Ave N does not have a stop sign and residents find it difficult to cross the street to get to the bus stop.

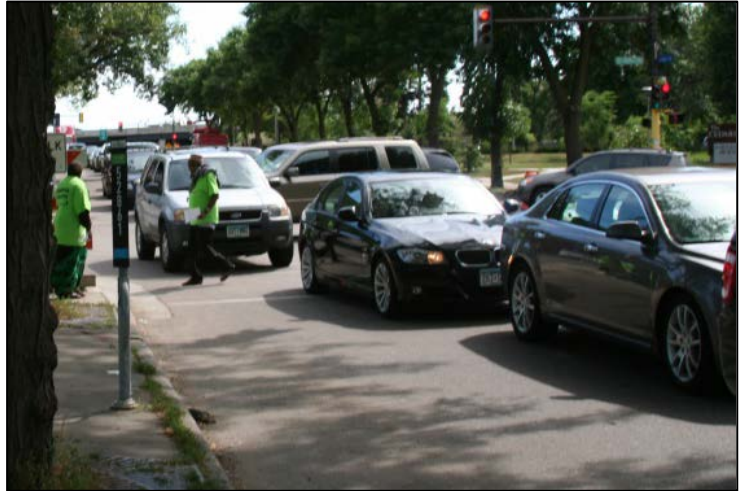
Cedar Ave/S 6th St: Heavy traffic density is intimidating to residents and creates a barrier when cars stop in crosswalks.

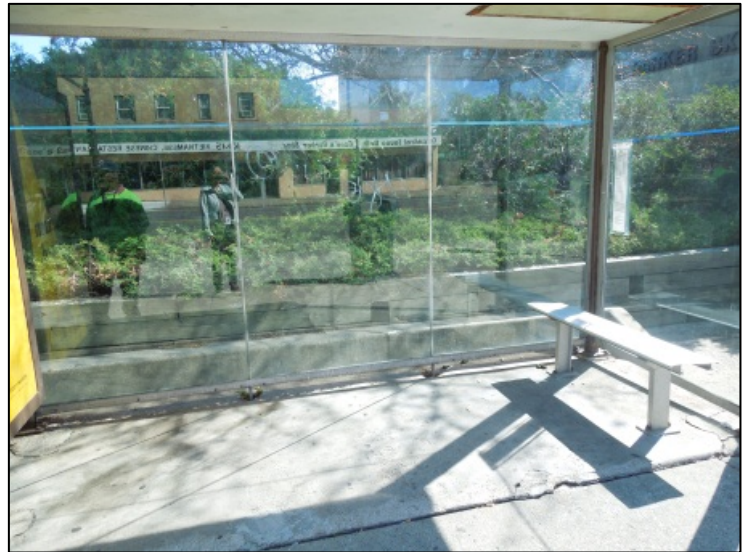
NE 18th ½ Ave & Central Ave N: residents would like a heat lamp in the bus shelter by their building

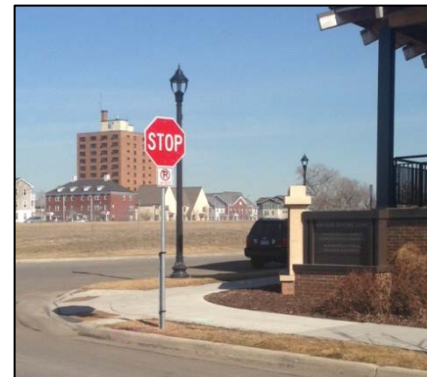
New stop sign at Dupont Ave N and 4th Ave N

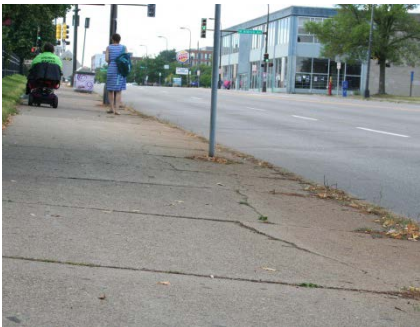
Uneven sidewalks/pavement		
Location	Concerns	Photo (if available)
W Broadway between Byrant Ave N/N Lyndale Ave (<i>see map 2, #1</i>)	Uneven, cracked sidewalk. Residents' scooters have fallen over

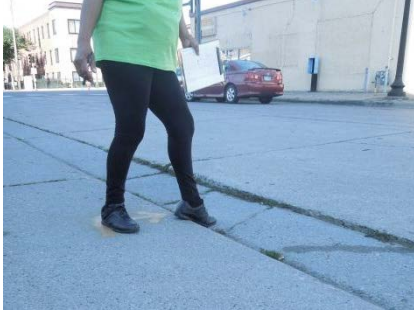
<p>Polk St NE between NE 18th ½ Ave/18th Ave NE (see map 4, #1)</p>	<p>Uneven sidewalk creates a bump that is difficult to navigate for people with walkers</p>

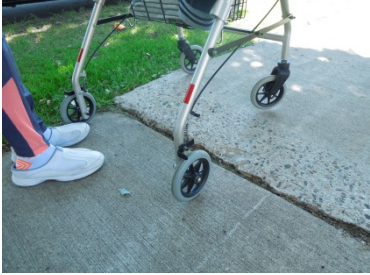
<p>Johnson St (see map 4 – not shown on the map)</p>	<p>Uneven sidewalks</p>

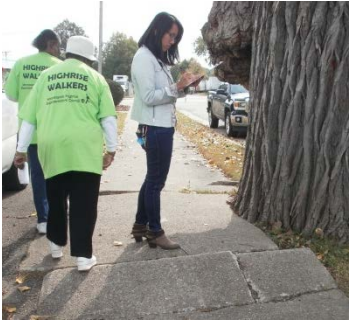
<p>Fremont Ave between Van White Memorial Blvd and Glenwood Ave (see map 3, #3)</p>	<p>Sidewalk is raised by a large tree</p>

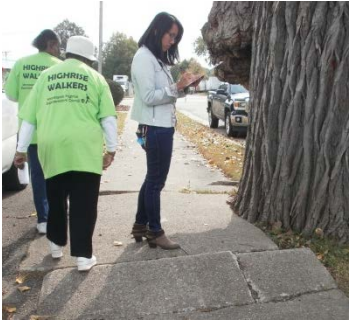
<p>Glenwood Ave between N Fremont Ave/ Dupont Ave (see map 3, #4)</p>	<p>Uneven sidewalks along the south side of Glenwood and a few on the north side</p>

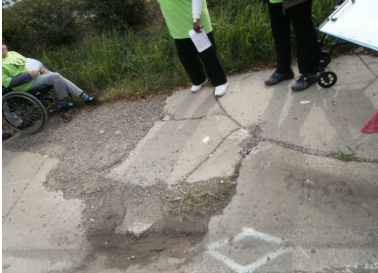
<p>Dupont Ave between N 4th Ave/Glenwood Ave (see map 3, #1)</p>	<p>Cracks along the sidewalk near the YMCA</p>

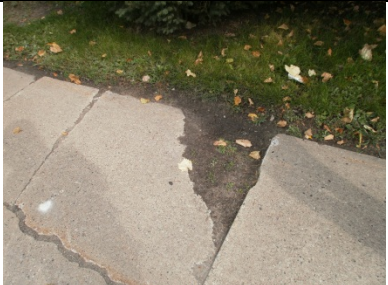
<p>E Franklin between S 28th Ave/ 27th Ave S (see map 6, #2)</p>	<p>Uneven driveways</p>

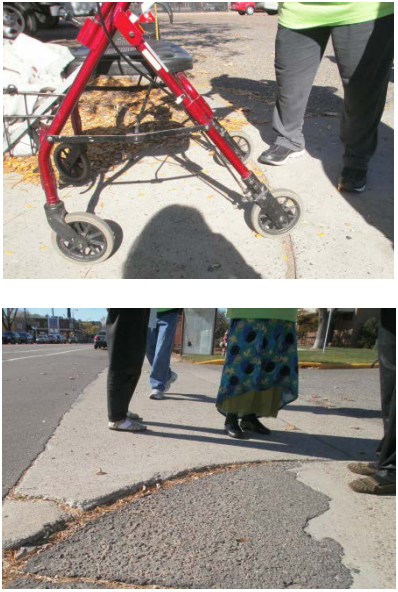
<p>Pillsbury Ave S between W Lake St/ W 31st St (see map 10, #3)</p>	<p>Uneven sidewalk covered in dirt and debris</p>

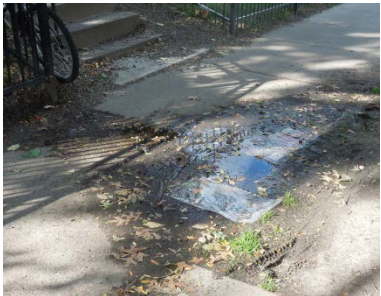
<p>W Lake St between Harriet Ave and Nicollet Ave (see map 10, #5)</p>	<p>Uneven sidewalks along the street</p>

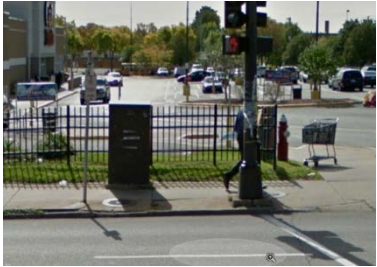
Obstructed and narrow sidewalks		
Location	Concerns	Photo (if available)
W Broadway Ave/ N Lyndale – corner sidewalk at Cub Food parking entrance (see map 2, #1)	Narrow sidewalk due to electricity box and traffic light poles

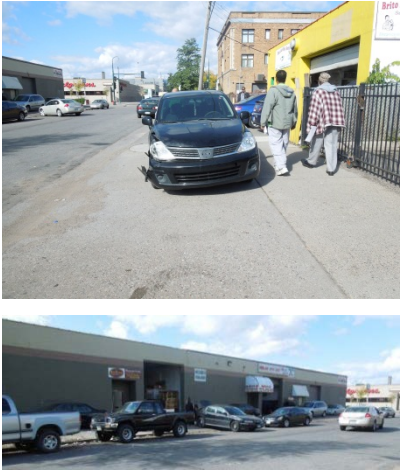
<p>Pillsbury Ave S – Between Midtown Greenway/W 31st St <i>(see map 10. #3 and #4)</i></p>	<p>Cars park on sidewalks and double park in front of local businesses in the area, creating sidewalk obstructions. Some cars may be parked on sidewalk by the mechanics located in the area. Residents report that they have complained to the local police station but have not seen any improvement.</p>

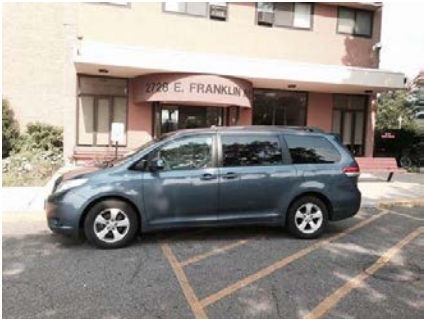
<p>2728 E Franklin Ave – MPHA parking lot <i>(see map 6, #1)</i></p>	<p>Cars park in front of the building main entrance ramp, blocking access to the building for people using wheelchairs and walkers.</p>

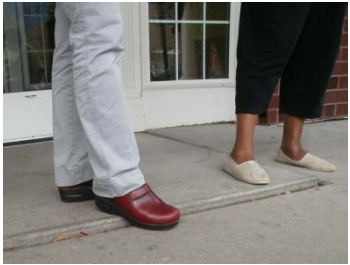
350 Van White Memorial Boulevard (<i>see map 3, #1</i>) (MPHA property)	Building entrance from the parking lot – ramp is uneven and too steep

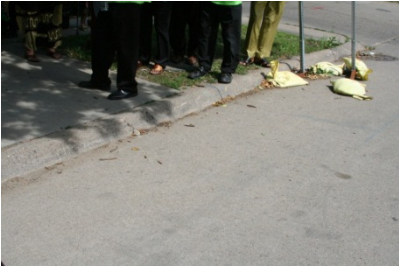
S 6 th St & 16 th Ave S/Cedars Ave (see map 7, #2)	The sidewalk adjacent to the Riverside Plaza parking entrance is not wheelchair accessible (no curb cut)

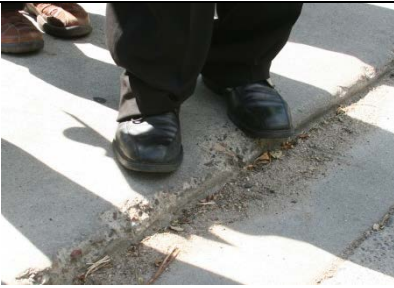
S 6 th St & 16 th Ave S/Cedars Ave (see map 7, #2)	Tripping hazard: driveway ramp into Cedars High Apartment parking lot does not transition into the street smoothly. Residents feel concerned because this route is frequently used to go to the Islamic Center across the street

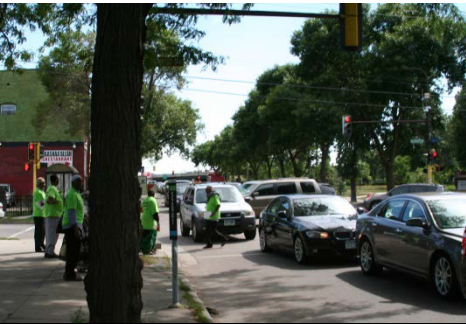
High traffic density and flow		
Location	Concerns	Photo (if available)
Cedar Ave/S 6 th St (see map 7, #4)	High traffic density results in cars blocking the intersections and crosswalks after light changes to red

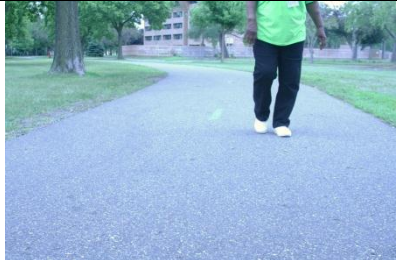
Lack of separation of bikers and walkers		
Location	Concerns	Photo (if available)
Memorial Parkway trail between 45 th Ave N and Humboldt Ave N. (see map 1, #4)	Unclear division between cyclists and pedestrians on the trail located just north of the property

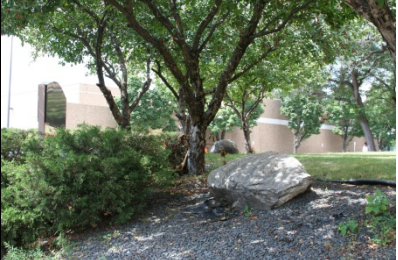
Personal safety concerns		
Location	Concerns	Photo (if available)
18 th Ave N/ West of N Lyndale Ave (see map 2, #4)	People are reported to doing drugs behind bushes

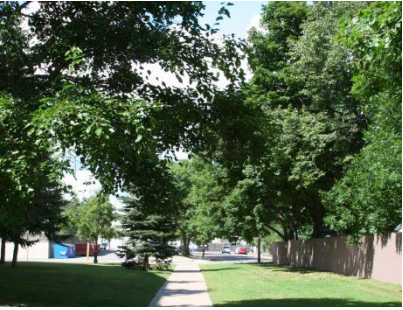
Insufficient lighting		
Location	Concerns	Photo (if available)
600 18 th Av N. – MPHA property (see map 2, #4)	No pedestrian lighting at the walking path east of the building

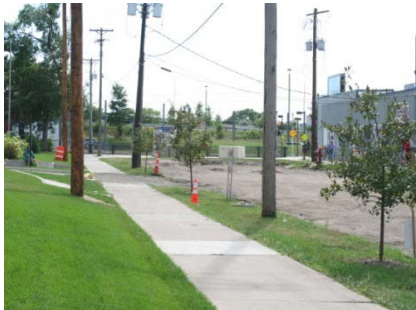
S 6 th St/16 th Ave S (see map 7, #1 and #2)	No adequate pedestrian lighting– personal safety concerns

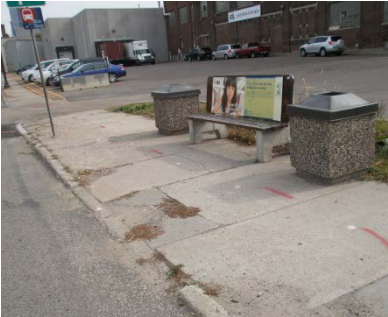
wheelchairs up at the driveway at Clare housing	
Central Ave NE/18 th Ave NE <i>(see map 4, #4)</i>	Poor snow clearance at bus stops	
Glenwood Ave/Dupont Ave <i>(see map 3, #5)</i>	Bus stops have uneven sidewalks, no bus shelter

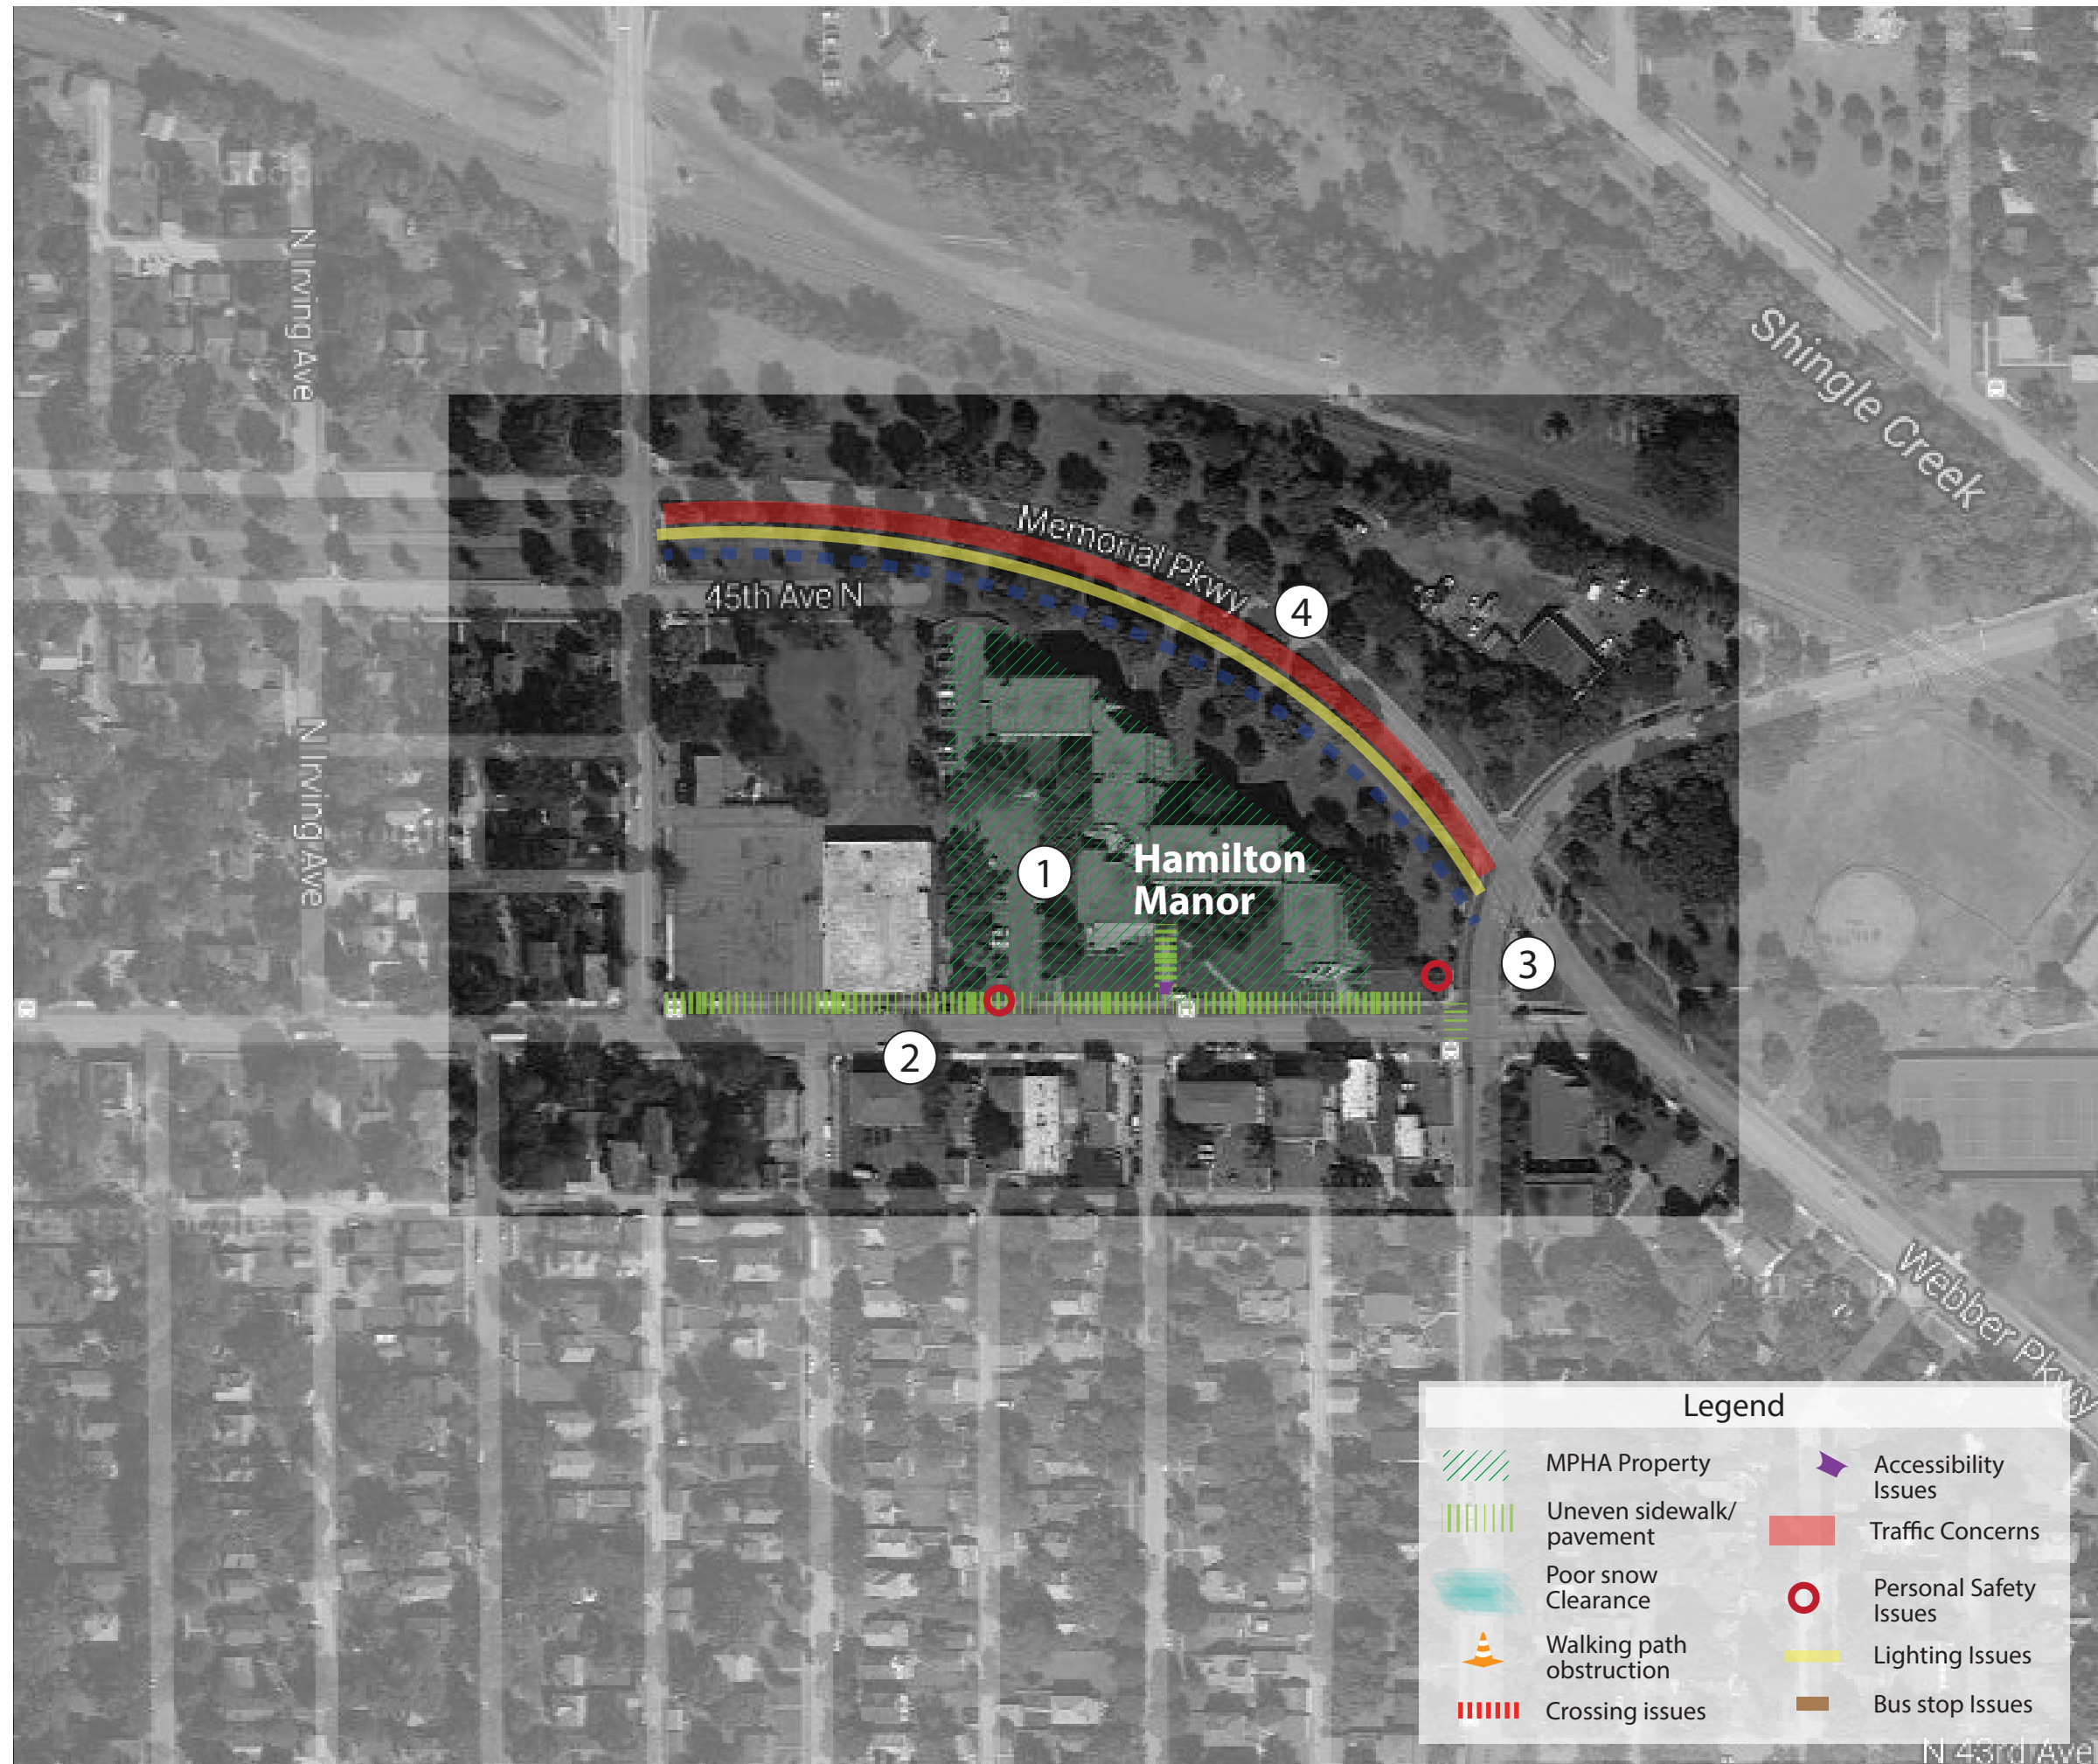
- ||| Uneven sidewalk - bumps/cracks
- Residents feel concerned that suspicious activity may take place inside in the cars that are parked in front of their property

- ||| Sunken manhole - tripping hazard
- Dense trees at corner - residents feel concerned about people hiding inside these trees

- Shared trail for cyclists and pedestrian; pedestrians are intimidated by cyclists.
- No pedestrian lighting
- No bench to rest on
(note that this symbol does not appear in the length)

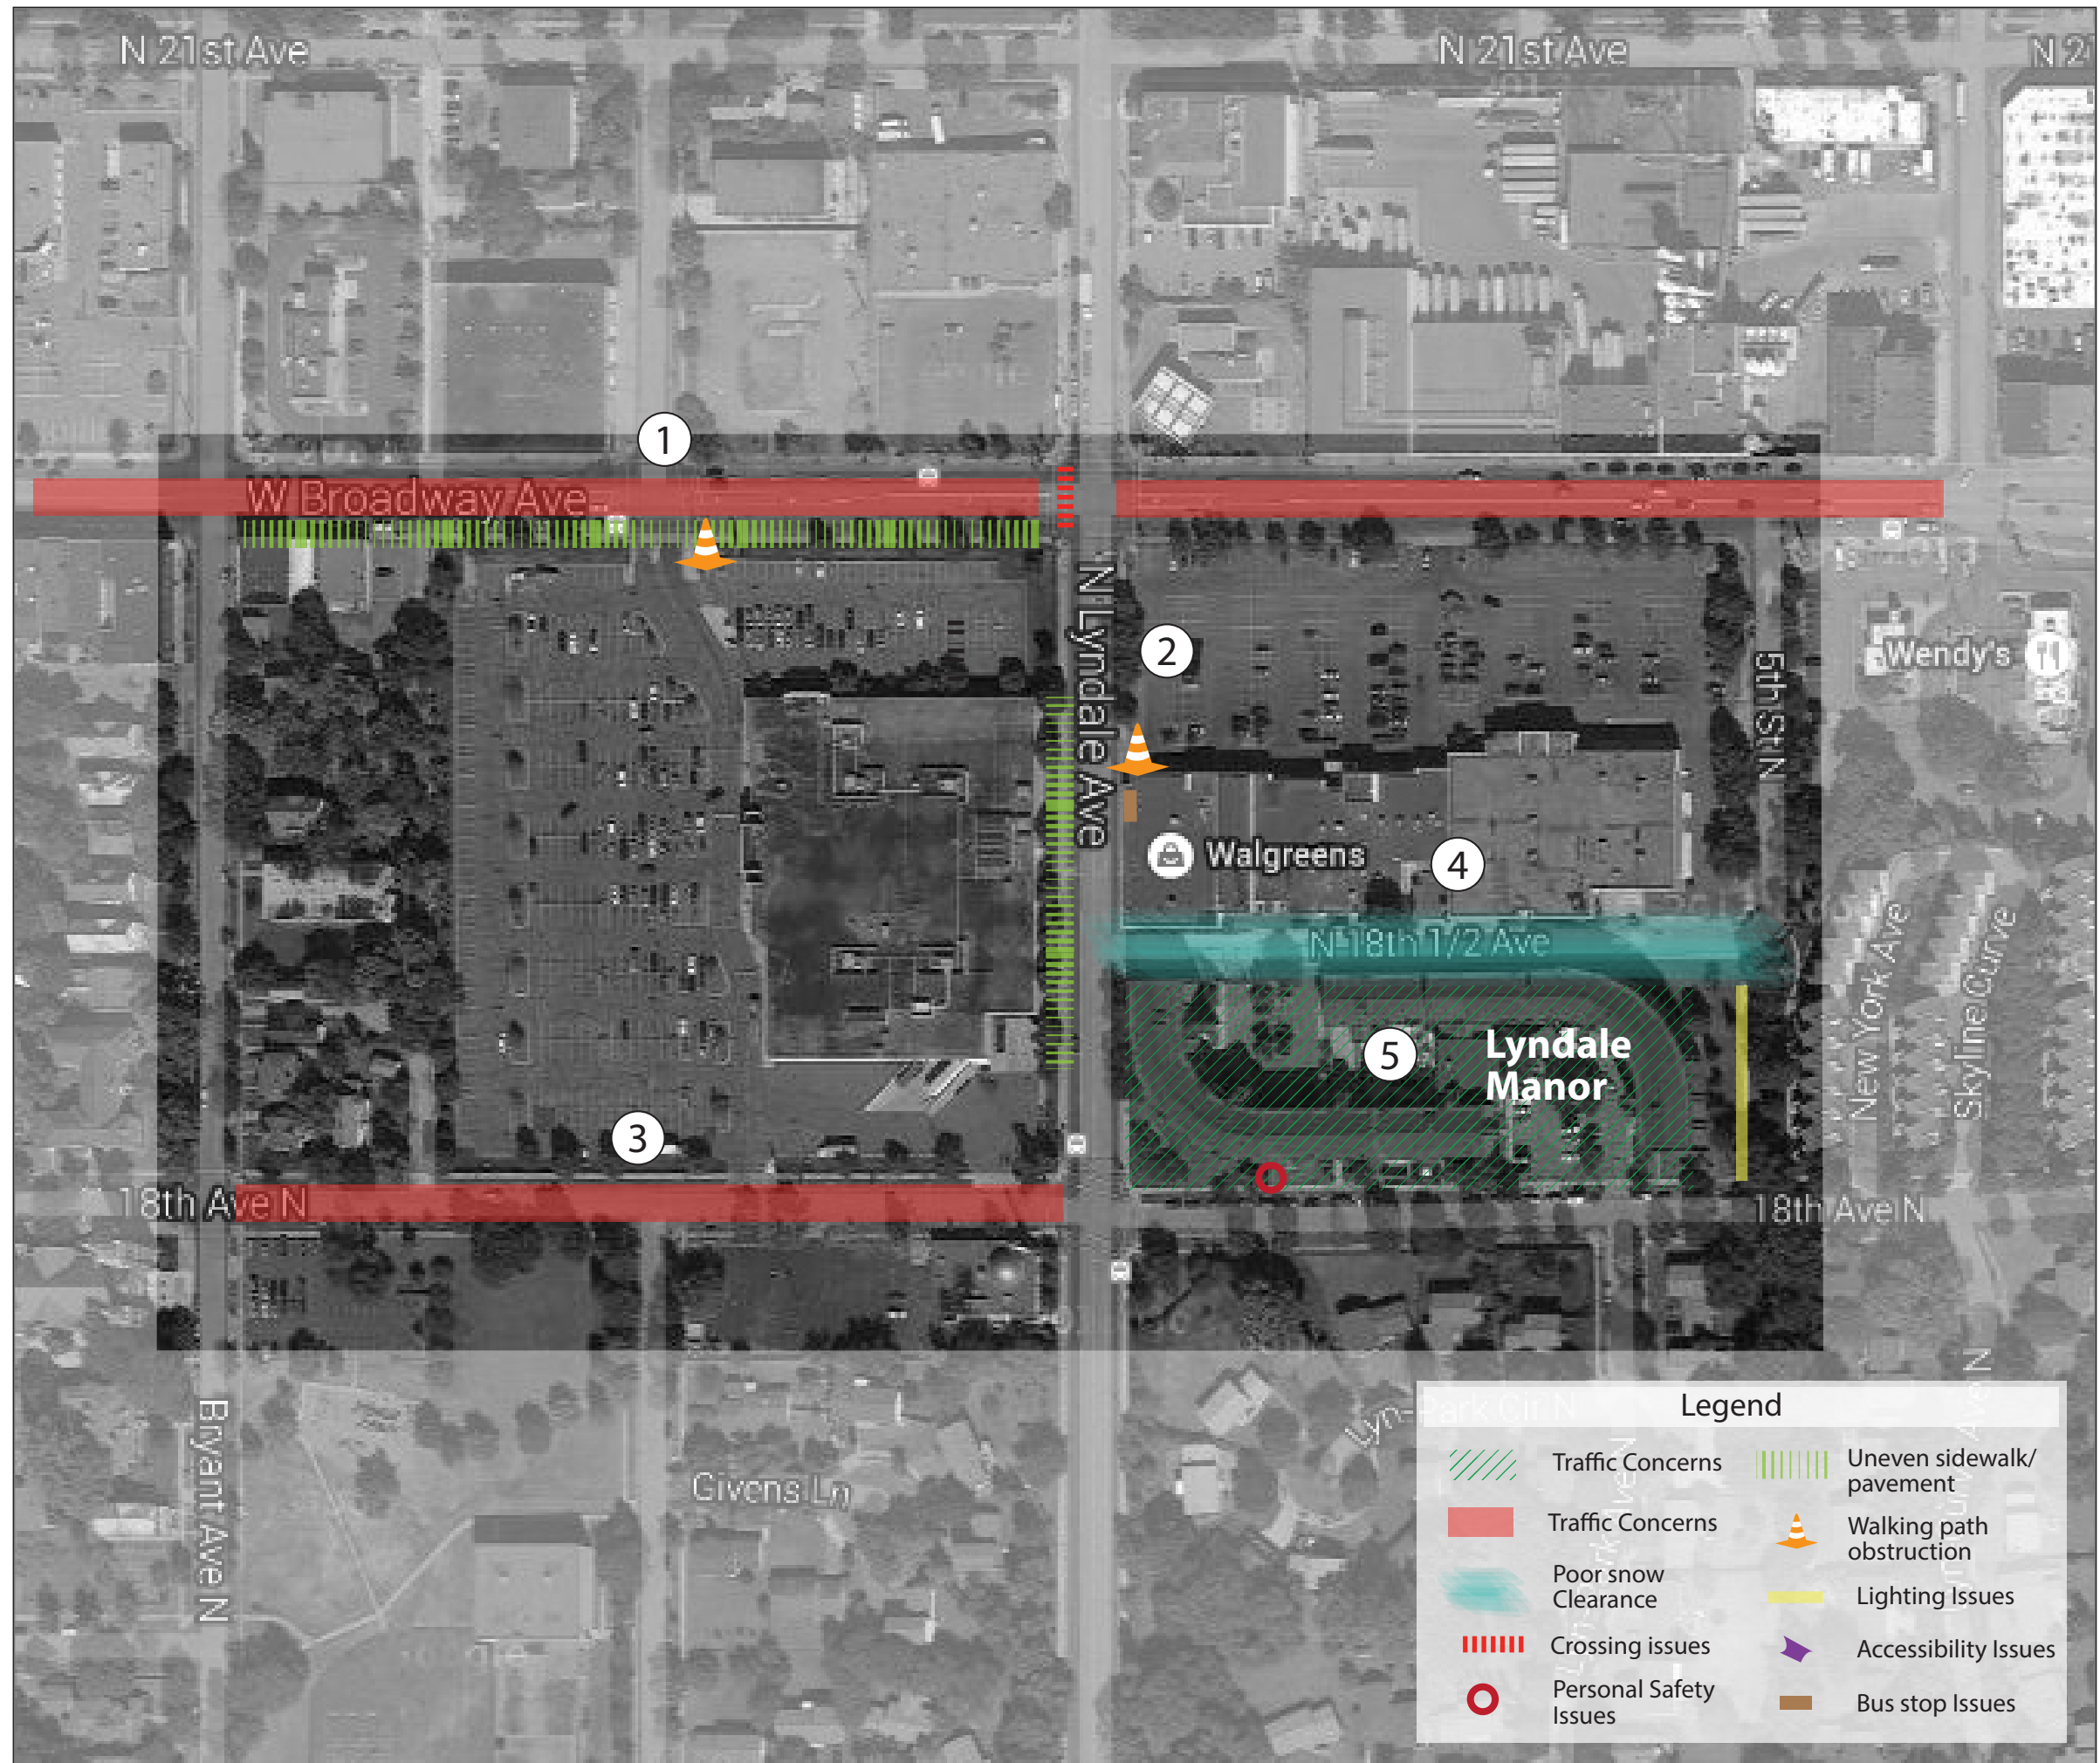
Map 3

- Building entrance from the parking lot - ramp is uneven and steep
- ||| Cracks along the sidewalk near the YMCA
- Sheets of ice form at the front sidewalk of the MPHA building

- ||| Uneven sidewalks
- Bus stops are very narrow and cracked; residents would like shelters at these stops and would like the stops to move to Van White Memorial Blvd. and 4th Ave.
- Fire hydrant narrows the sidewalk near the bus stop
- ||| No marked crosswalk - scary to cross, fast traffic

- High traffic speeds; no traffic control at intersection

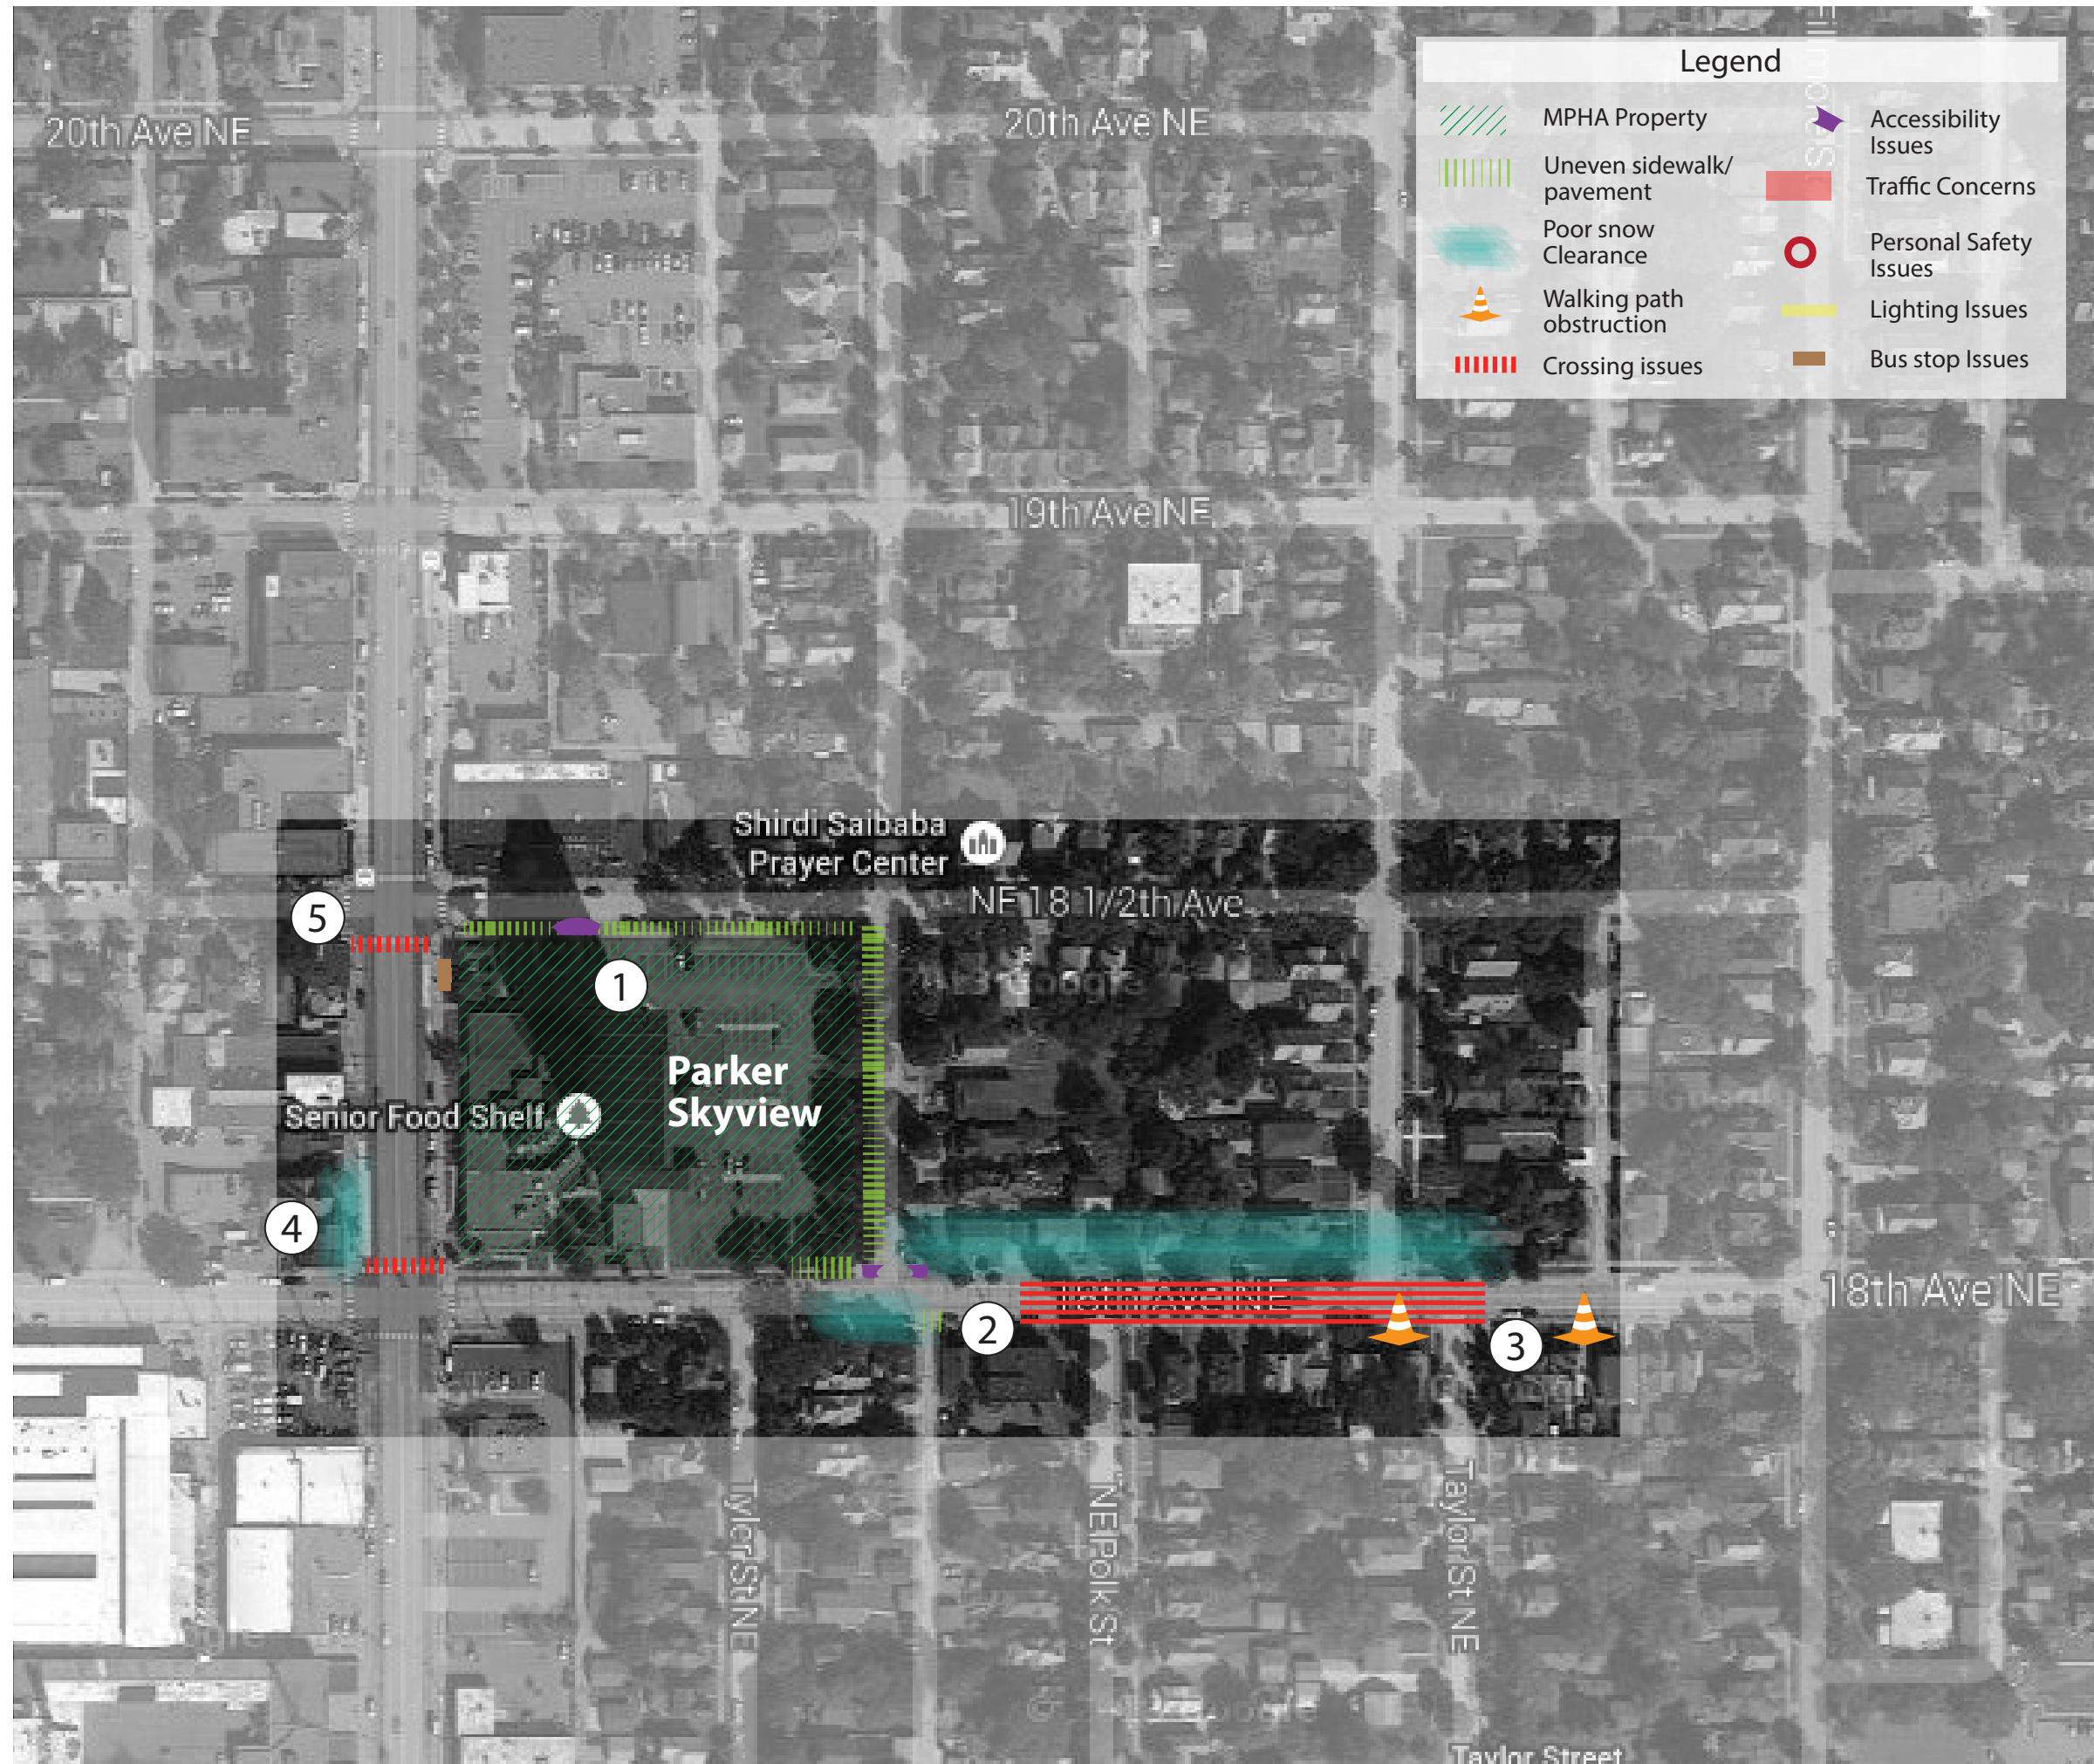
Map 5

- ||| Uneven sidewalks on NE 18 1/2 Ave in front of property
- ▶ Sidewalks have steep slopes where they cross the parking lot entrances, which causes problems for wheelchairs and walkers
- ||| East of property - uneven sidewalks

5 NE 18th 1/2 Ave/Central Ave NE

- ||| Not enough crossing time
- Bus stop - not enough bench space and heat lamp is needed

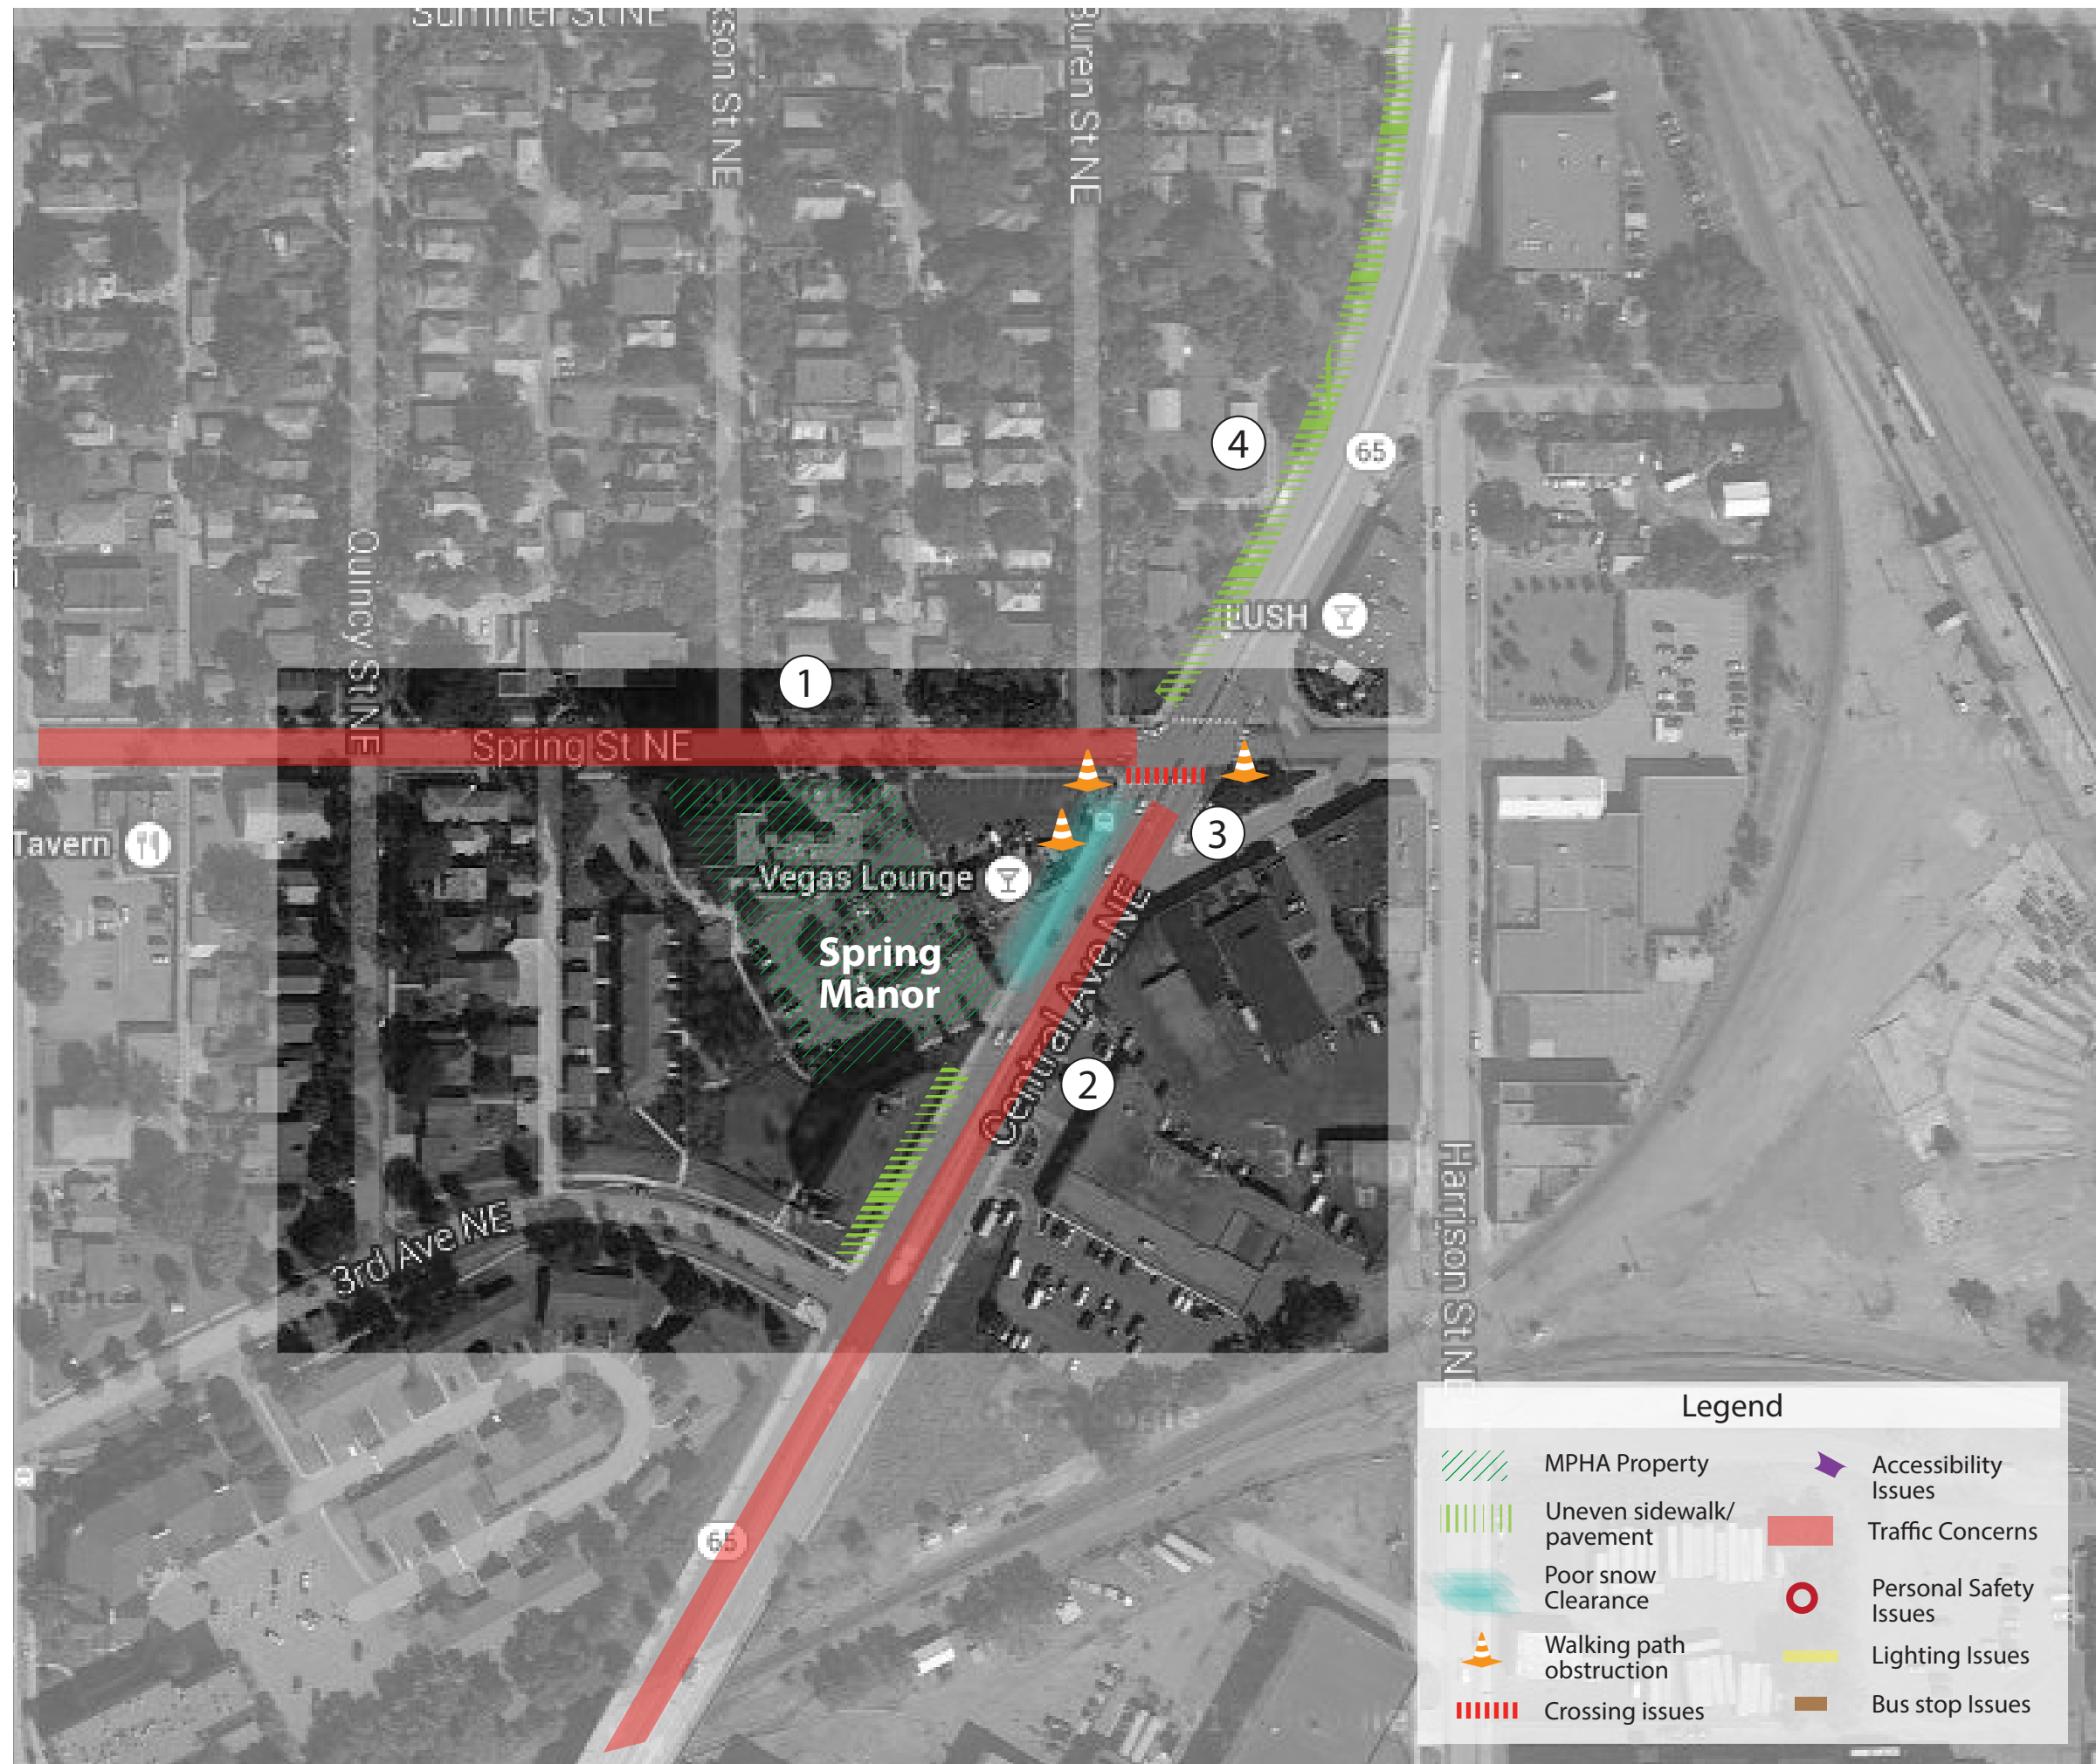
Central Ave - North of Spring

- ||| Uneven sidewalks (route to community garden)
