Barriers to Walking for Public Housing Highrise Residents

Findings from 2014 Listening
Sessions and Walking Audits

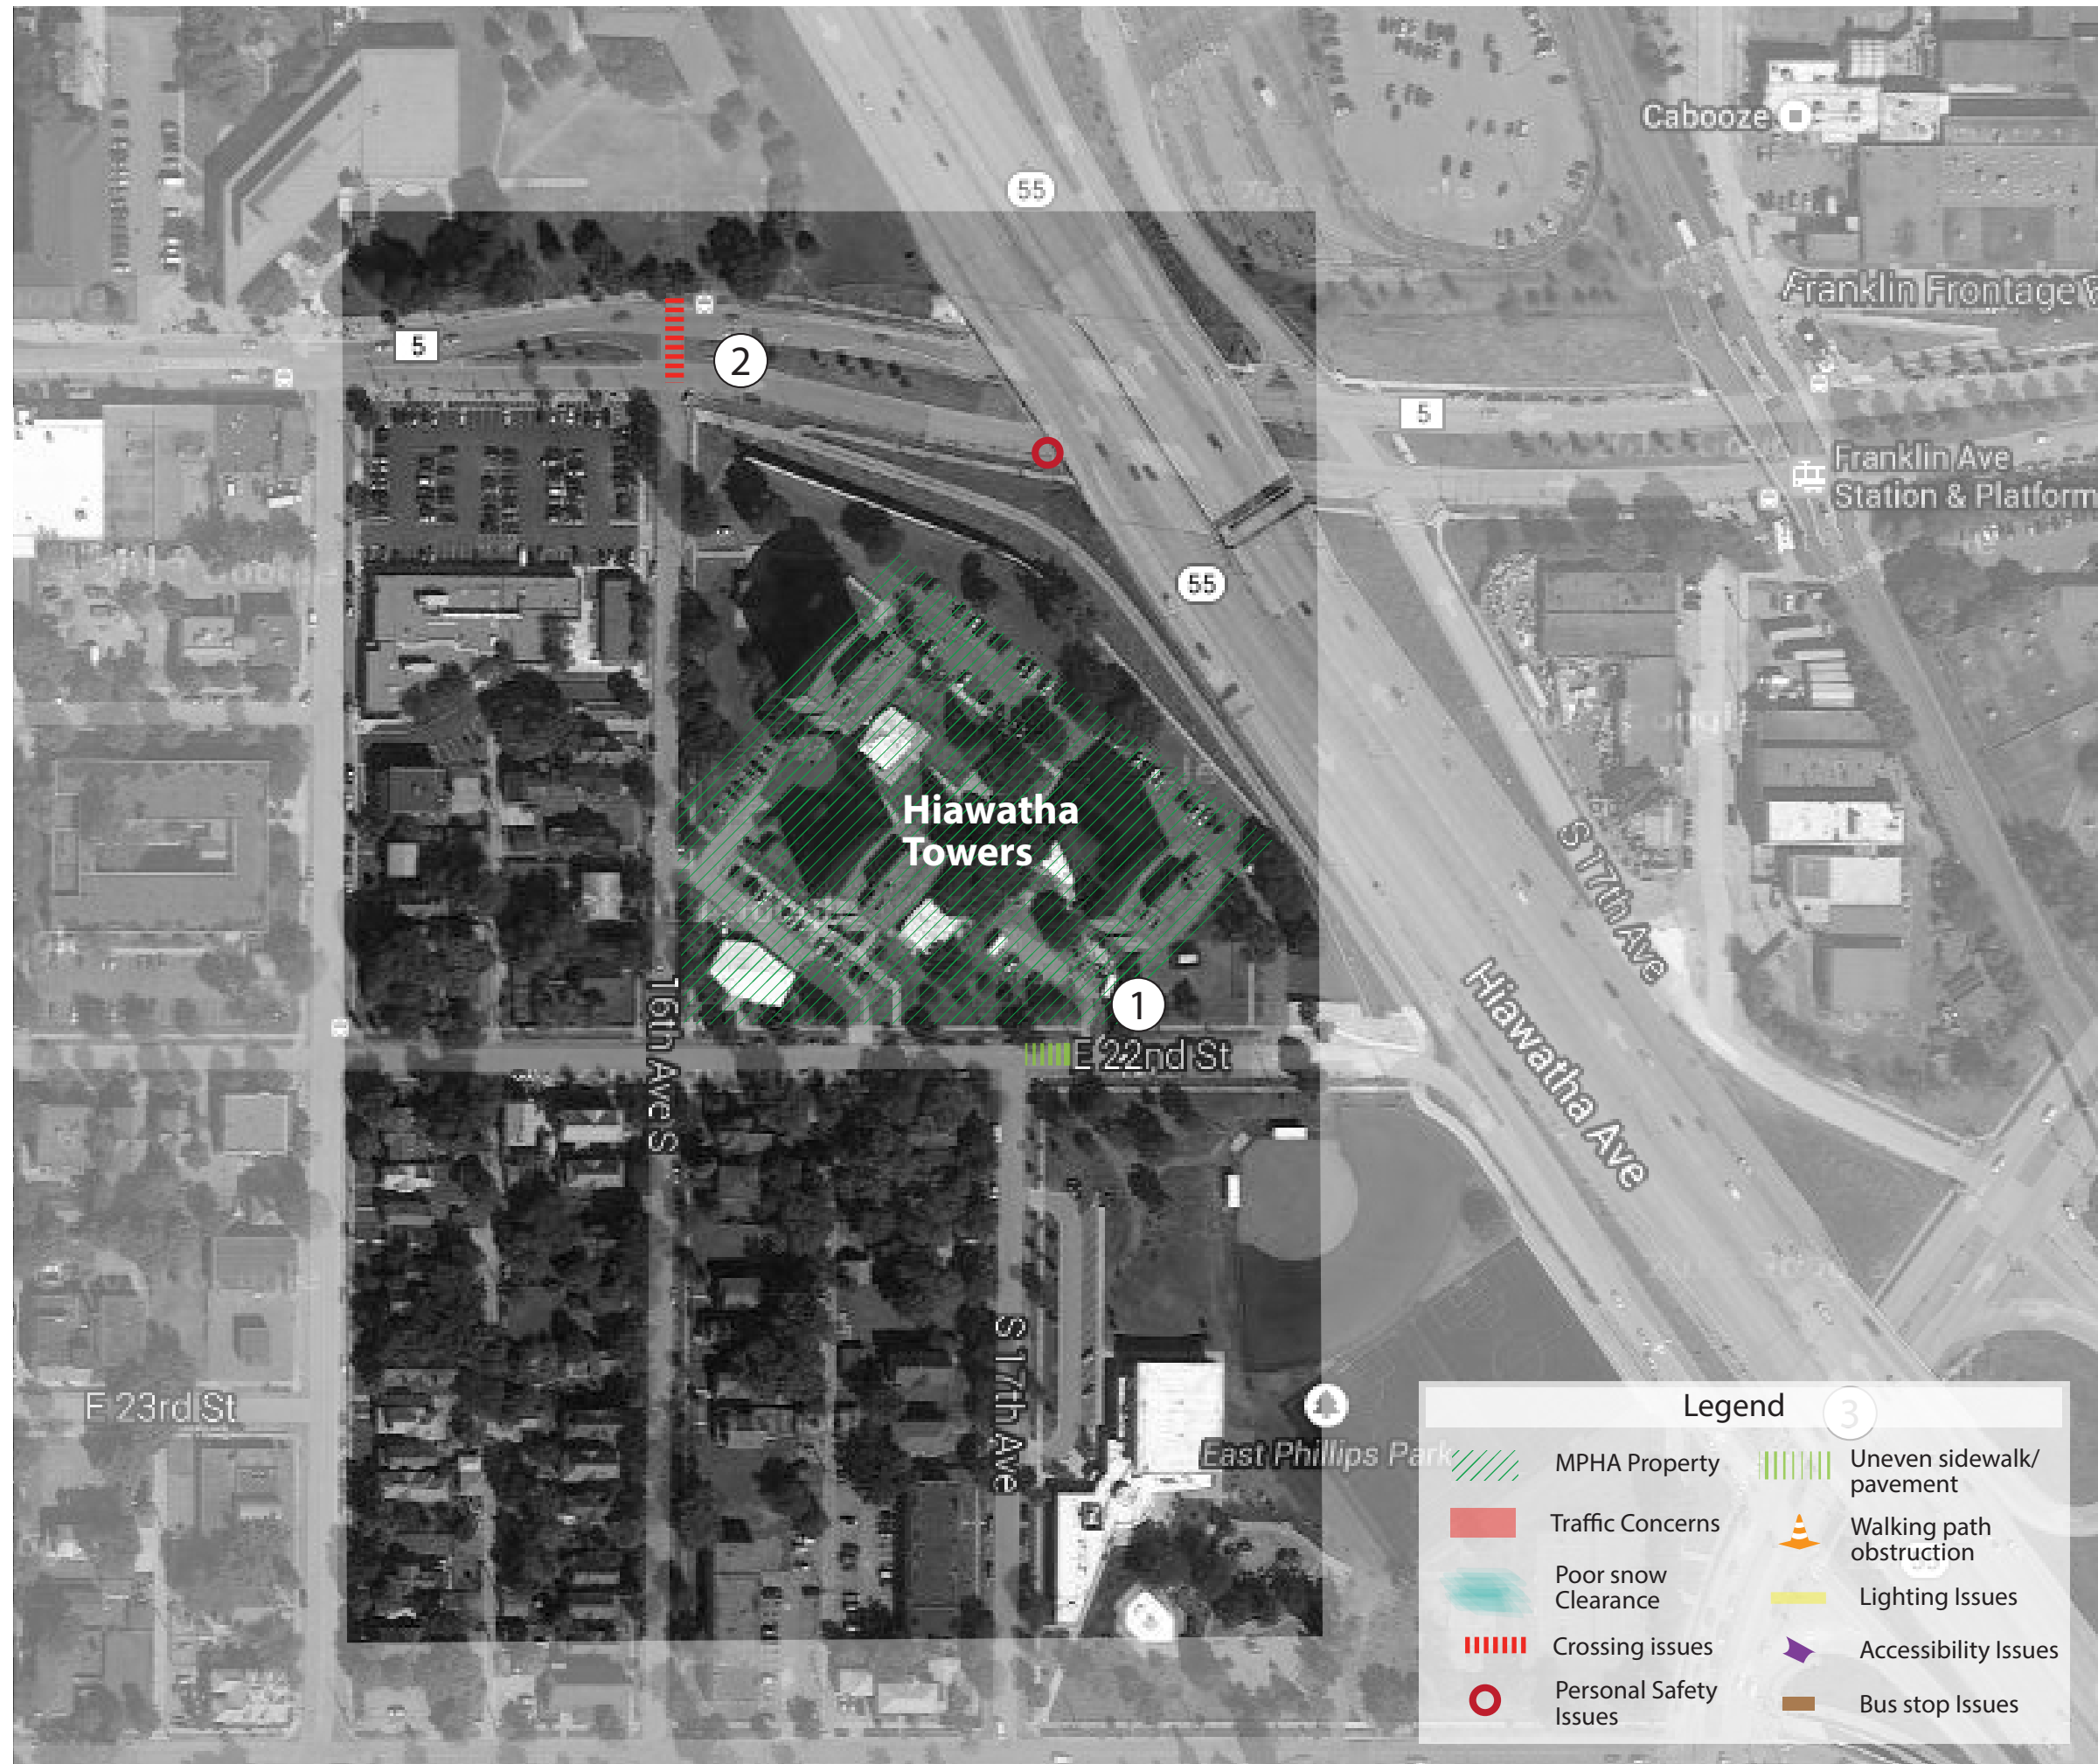
Map 9

③ **Hiawatha Ave Bridge**

○ Personal safety concerns - under the bridge, people are intoxicated and pedestrians get mugged

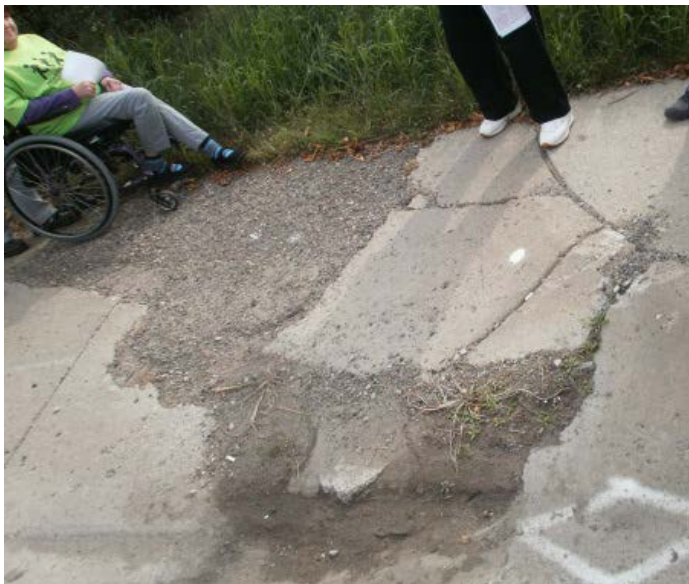
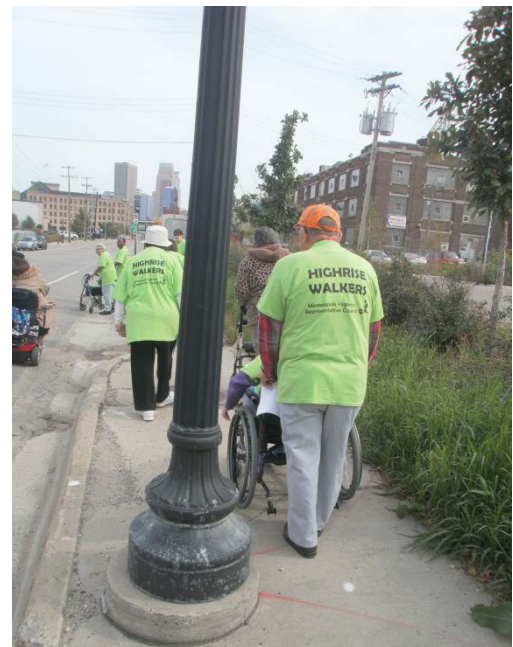
- **Sidewalk conditions:** The sidewalks are cracked; there are no boulevards, and they are relatively narrow. In some places, sidewalks are further narrowed by obstructions like light posts and fire hydrants. The photos below illustrate some of these challenges. Both photos below show sidewalks on the south side of Glenwood just west of Dupont.

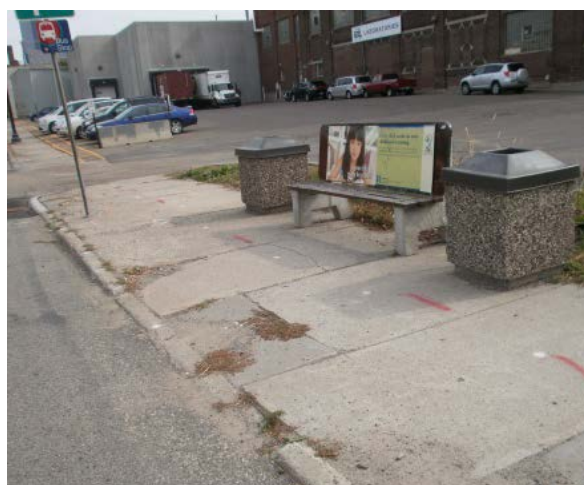
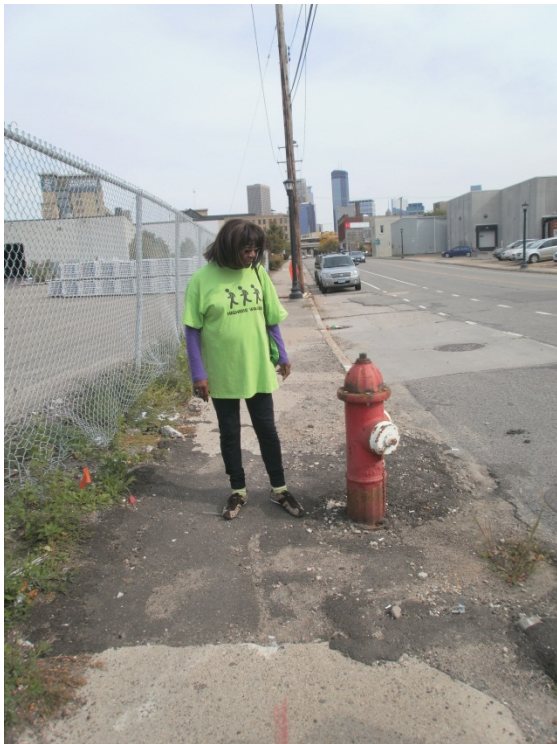
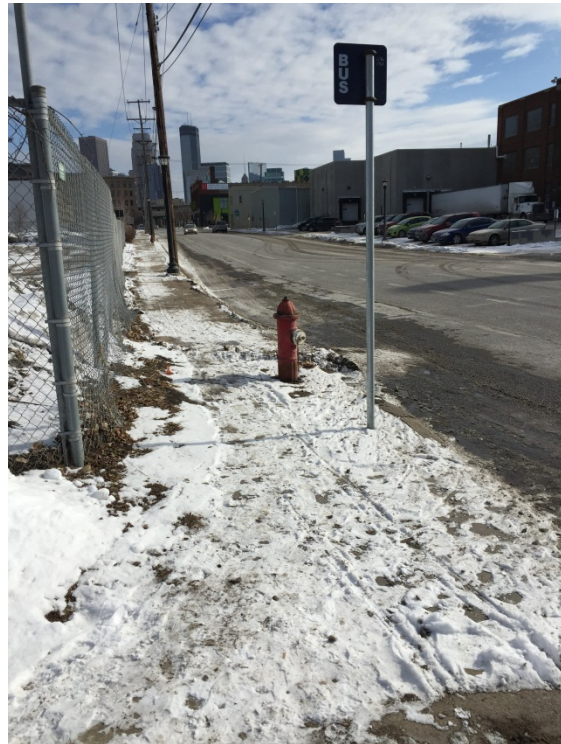
- **Bus stop conditions:** The sidewalks at the bus stops are narrow and in relatively poor condition. Residents would like to see shelters at the bus stops. The picture below shows the bus stop on the south side of Glenwood. The pictures on the next page show the bus stop on the north side of Glenwood in the fall (which shows the pavement condition) and in the winter, when it is often not cleared of snow.

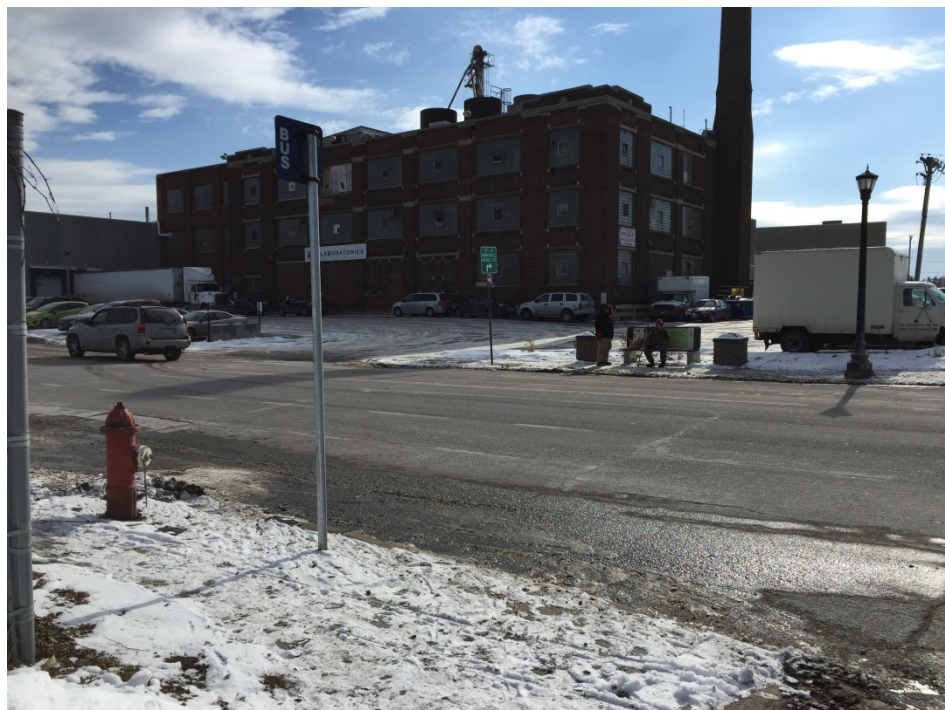
- Crossing Glenwood: Residents getting off of or onto the eastbound #9 bus must cross Glenwood Avenue. This is difficult for residents because the street, while not exceptionally wide, can take some time to cross for people who are elderly or who have disabilities. Residents also feel that cars traveling down this section of Glenwood move too fast. Cars traveling on Glenwood between Lyndale and Cedar Lake Road do not have to stop at any traffic lights or stop signs. During rush hour, the volume of cars is higher, and residents find they have to wait a long time to find an interruption in traffic in order to cross the street. The photo below shows where residents must cross Glenwood Avenue to get to the bus stop on the south side of the street.
